REPORT OF INVESTIGATION

Fatal Powered Haulage Accident
October 5, 2013

Pattiki Mine
White County Coal LLC
Carmi, White County, Illinois
ID No. 11-03058

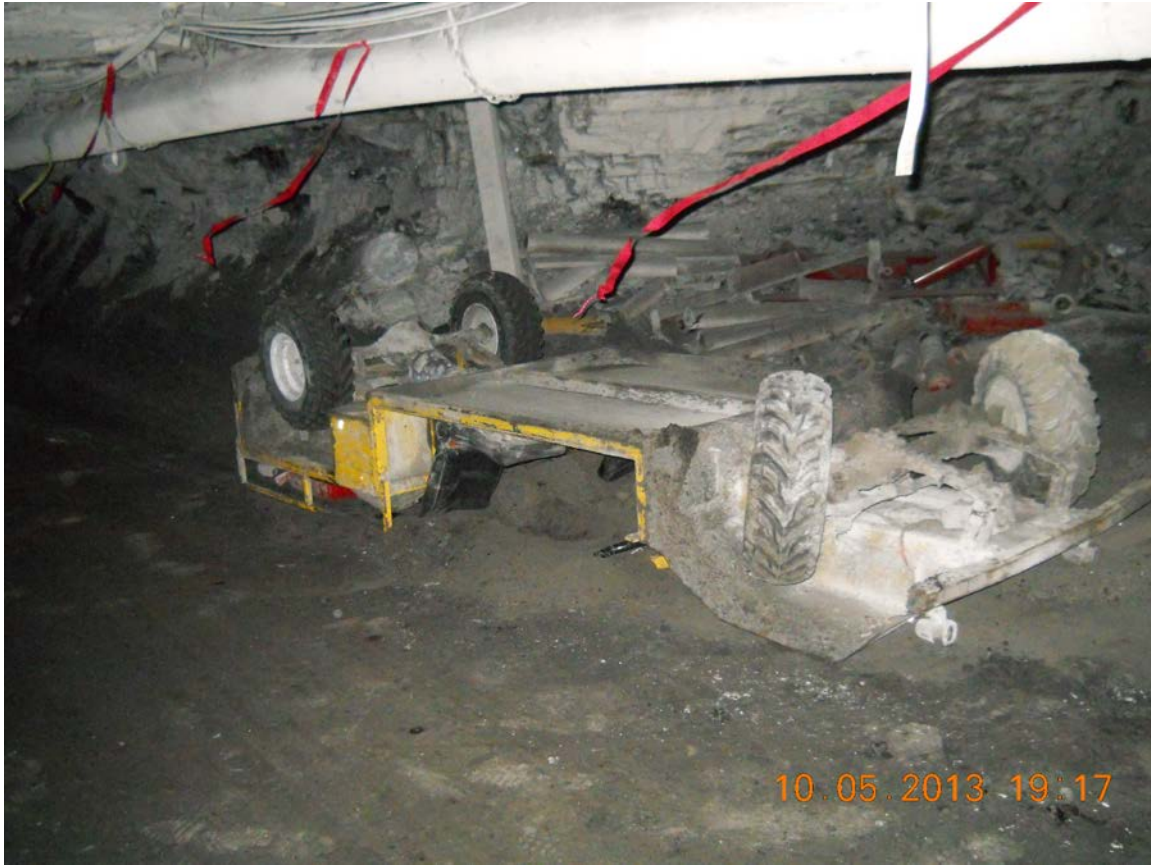
Overtuned Battery-Powered Personnel Carrier

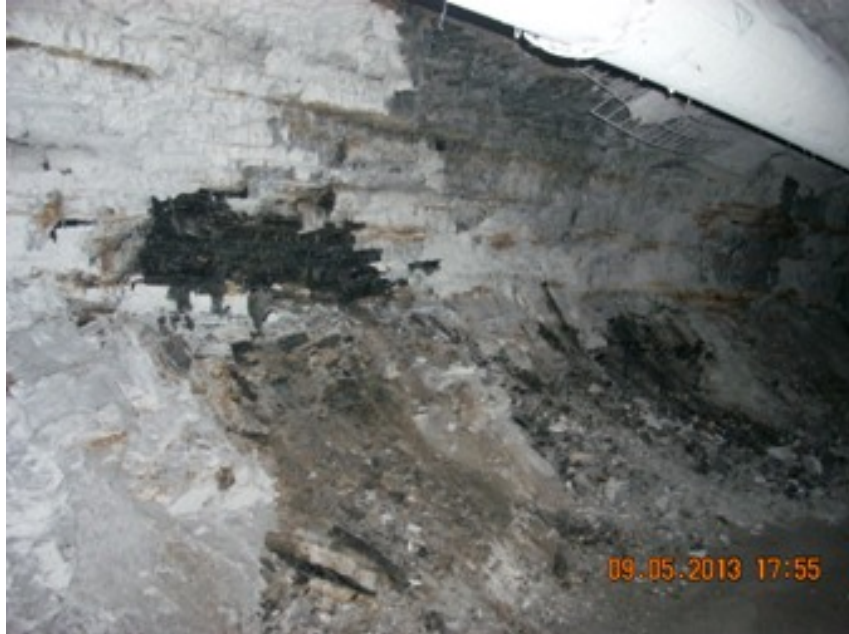
Evidence at the scene of the accident, however, does not support Brown's account of the carrier swerving and hitting the rib. There were no visible tire marks or disruption of the soft wind row of raw coal and rock along the left rib to indicate that the carrier hit or ran up on the rib (Appendix B).

Left rib at accident site, undisturbed by personnel carrier tracks.

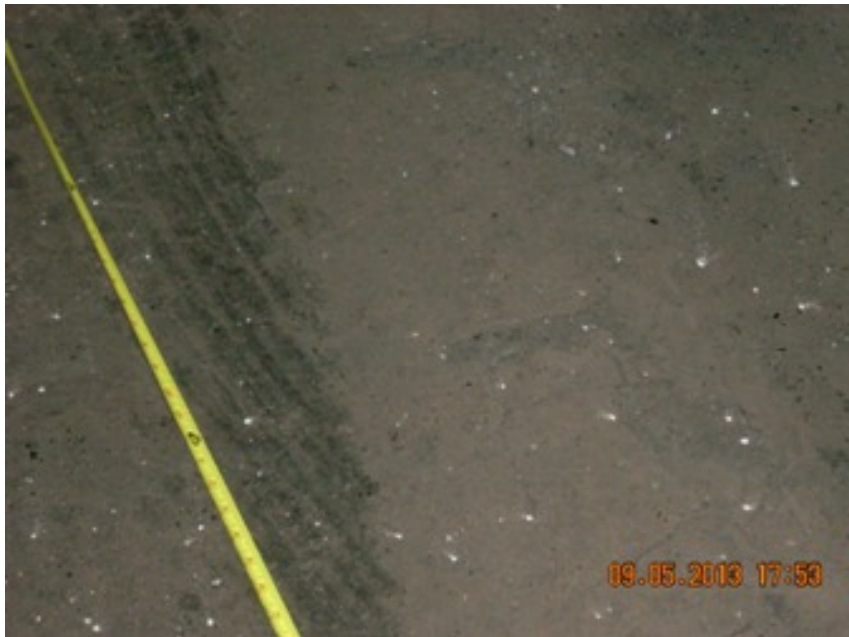
Additionally, there was a fresh skid mark approximately 14.5 feet in length, that indicated that one tire of the No. 7 personnel carrier skidded in a straight line, with respect to the entry, while the wheels were turned to the left (Appendix B). The tires on this personnel carrier have a unique and pronounced alternating tread. A tire will not leave this type of pattern, unless it was skidding.

Skid mark – close up

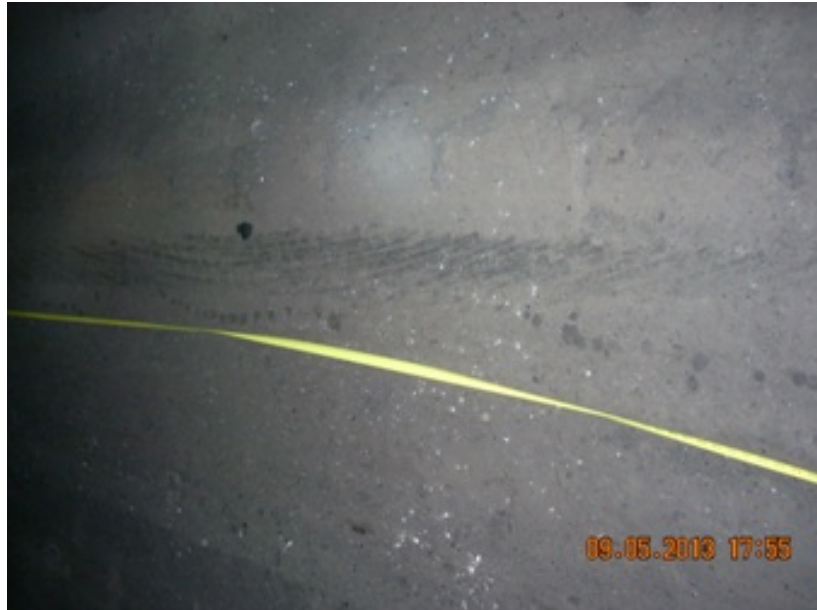
Skid mark – wide angle photo

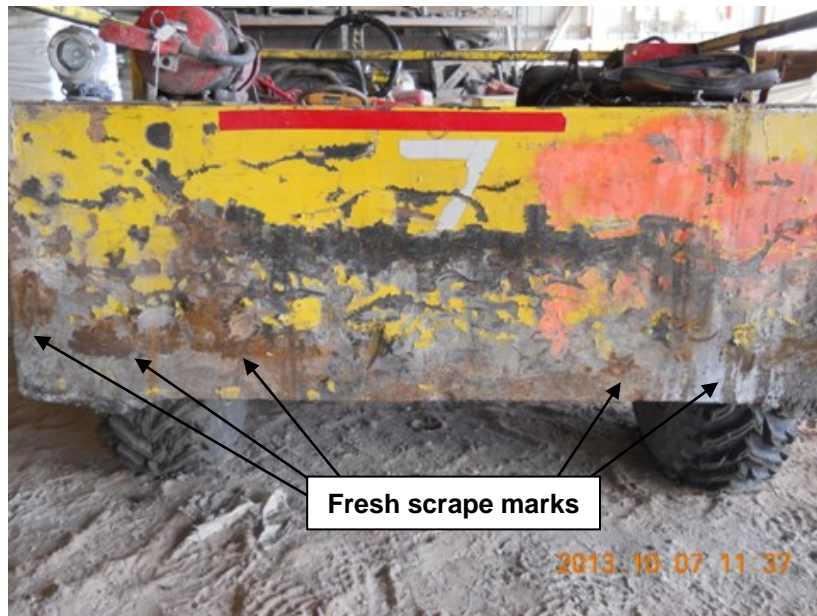
MSHA accident investigators found fresh scrape marks on the rear bumper of the No. 7 battery-powered personnel carrier, which indicated that this carrier had recently been pushed (Appendix B). Yellow paint markings on the front bumper of the company No. 7359 diesel-powered carrier indicate that it had recently pushed something with similar paint as the paint on the No. 7 personnel carrier (Appendix B). The bumper of the diesel-powered carrier matches some of the fresh scrape markings on the rear bumper of the No. 7 personnel carrier.

Rear bumper of company No. 7 battery-powered personnel carrier

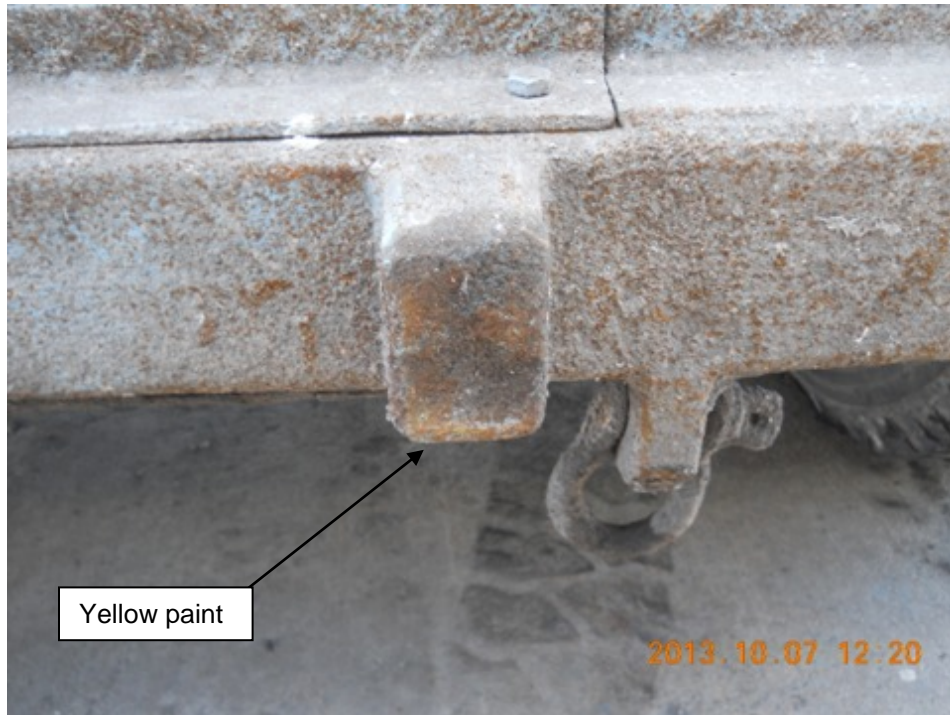
Front bumper of company No. 7359 diesel-powered carrier

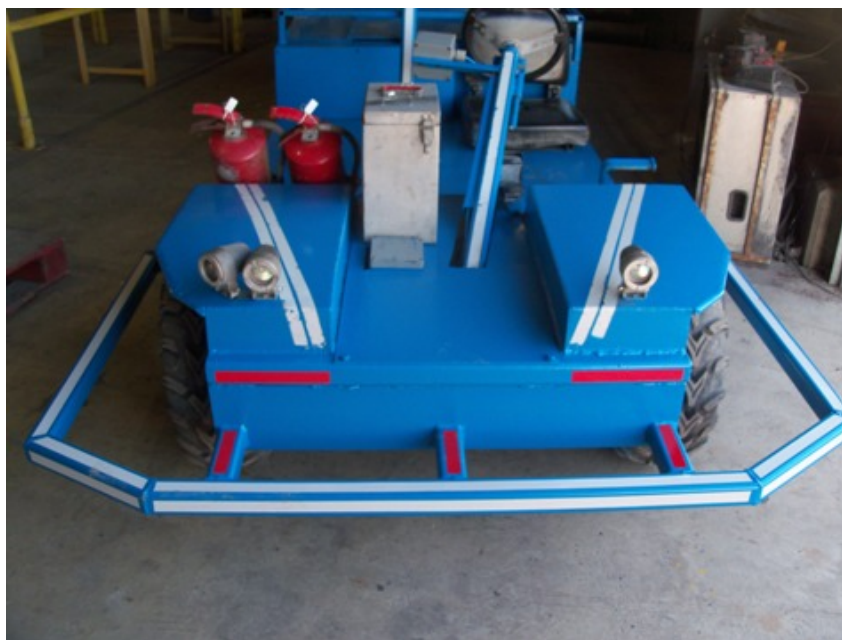
Modifications made by mine operator to battery-powered carrier

In addition to reducing the speed of the personnel carriers, the mine operator is in the process of re-manufacturing the front end of the carriers with a bumper extension that will prevent the carrier from getting close to the rib sloughage/piles of material left behind from grading the roads (Appendix B).

The mine operator has begun the process of installing bumper extensions on the non-permissible battery-powered carriers to aid in preventing them from potentially traveling up rib sloughage and wind rows of material left over from grading in the secondary escapeway (travelway). The mine will also continue to
