# Hanson Aggregates Midwest, LLC Dry Fork Sand & Gravel

Fatal Accident: July 10, 2015

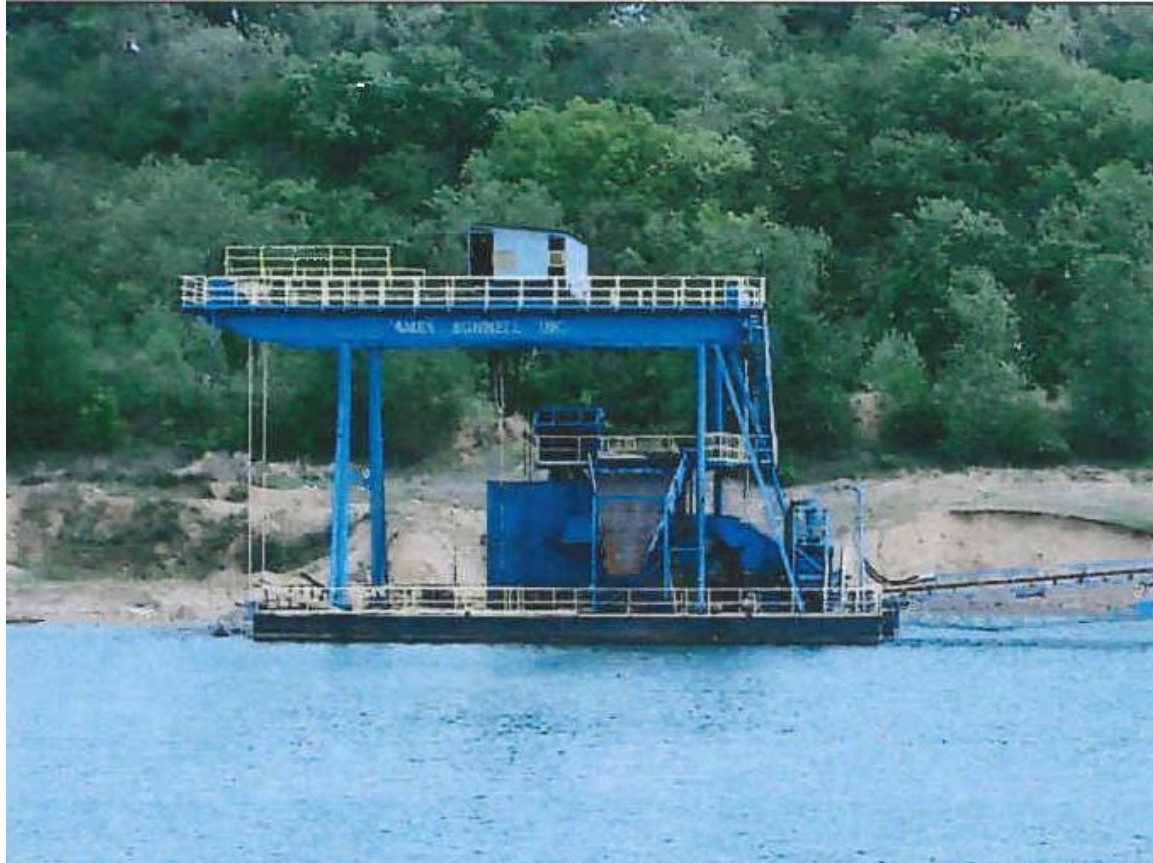
**Dredge prior to the accident in Spring 2015**

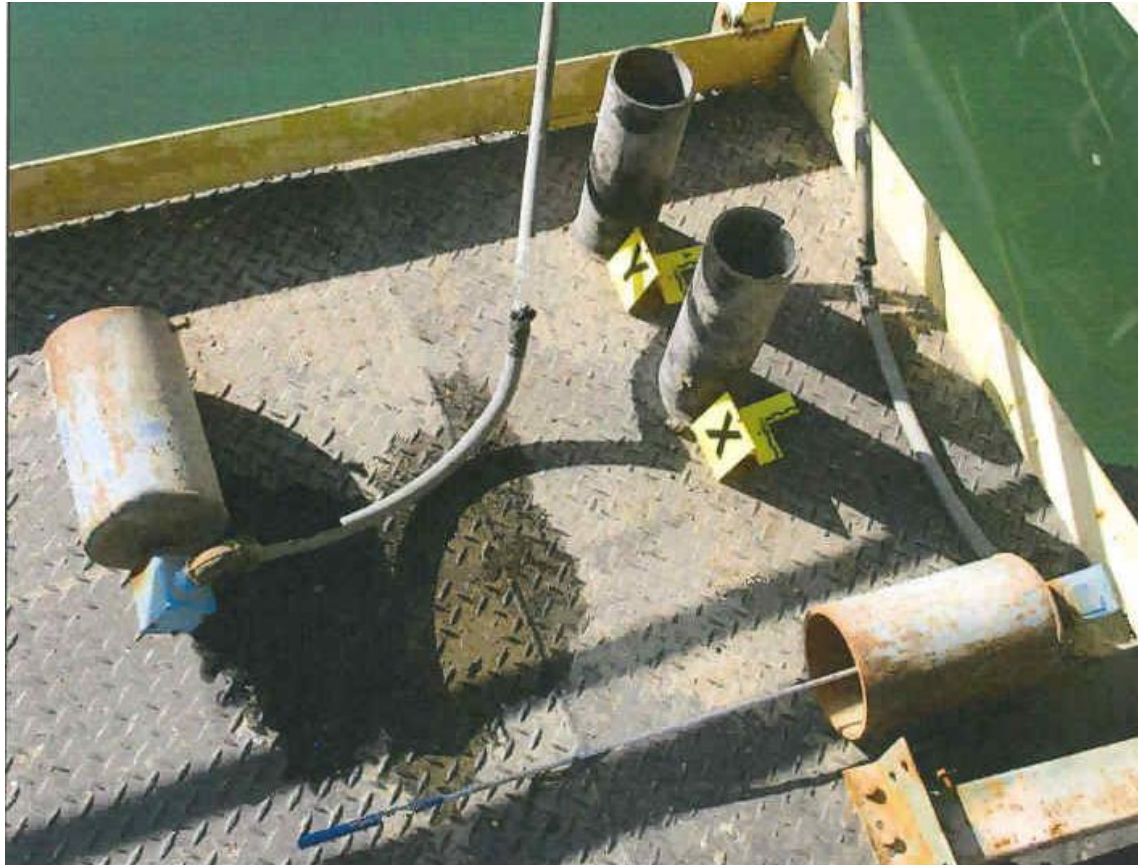
## **Overload sensors and mounting pipes**

- The overload switches that prevent excessive submersion or tipping had been disabled
- The access covers into the pontoons did not have watertight gaskets and were not fastened down as required
- The dredge crew was not following the manufacturer's procedure for retrieving a stuck bucket
- Not all crew members had training on the dredge operations

Note the missing rod on one sensor and the electrical tape on the other sensor. The fastening bolt is visible at the base of the left hand mounting pipe section.

Management policies and controls were inadequate. Mine management participated in the removal of the dredge's pontoon overload sensors and knew about its unfastened hatches and did not correct these conditions before continuing to operate the dredge.

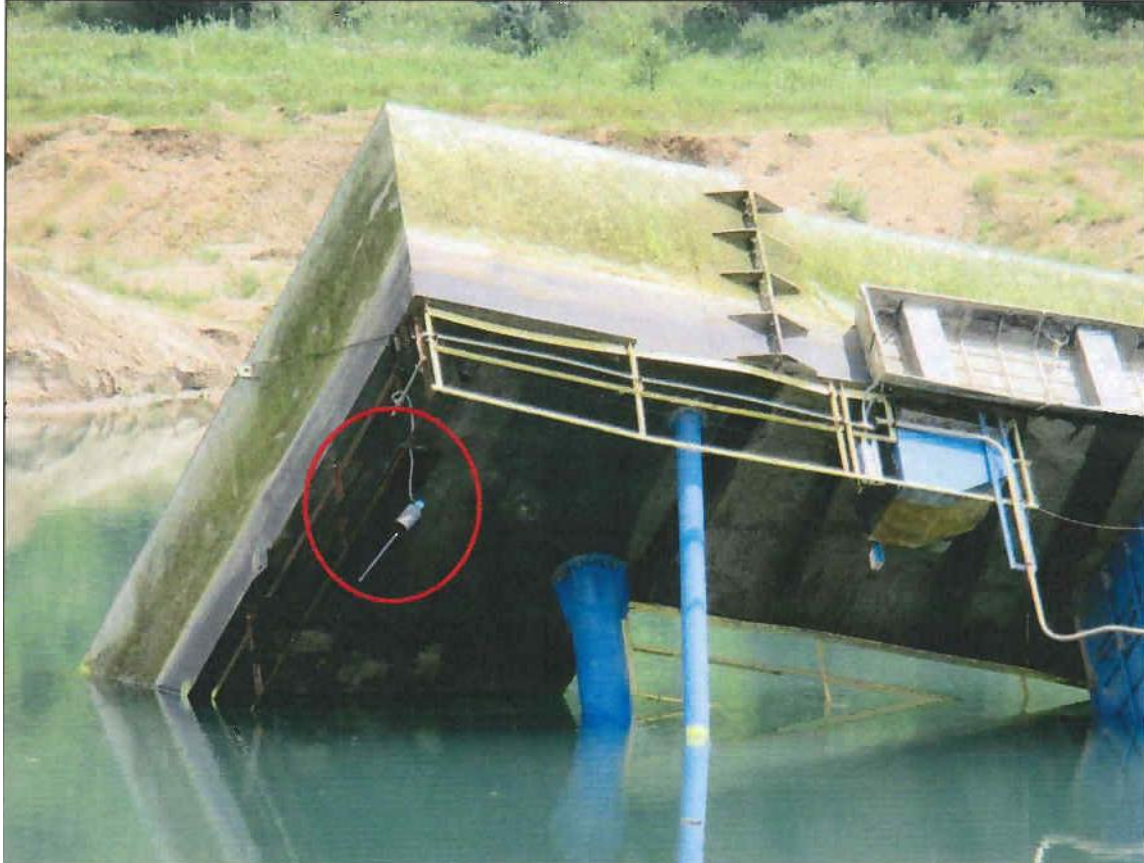
## **Dredge in water**

Note missing hatch cover and hanging overload sensor.
