REPORT OF INVESTIGATION

Surface Nonmetal Mine
(Dimension Sandstone)

Fatal Machinery Accident
March 23, 2015

Kane's Quarry
Kane's Quarry
Montrose, Susquehanna County, Pennsylvania
Mine I.D. No. 36-10136

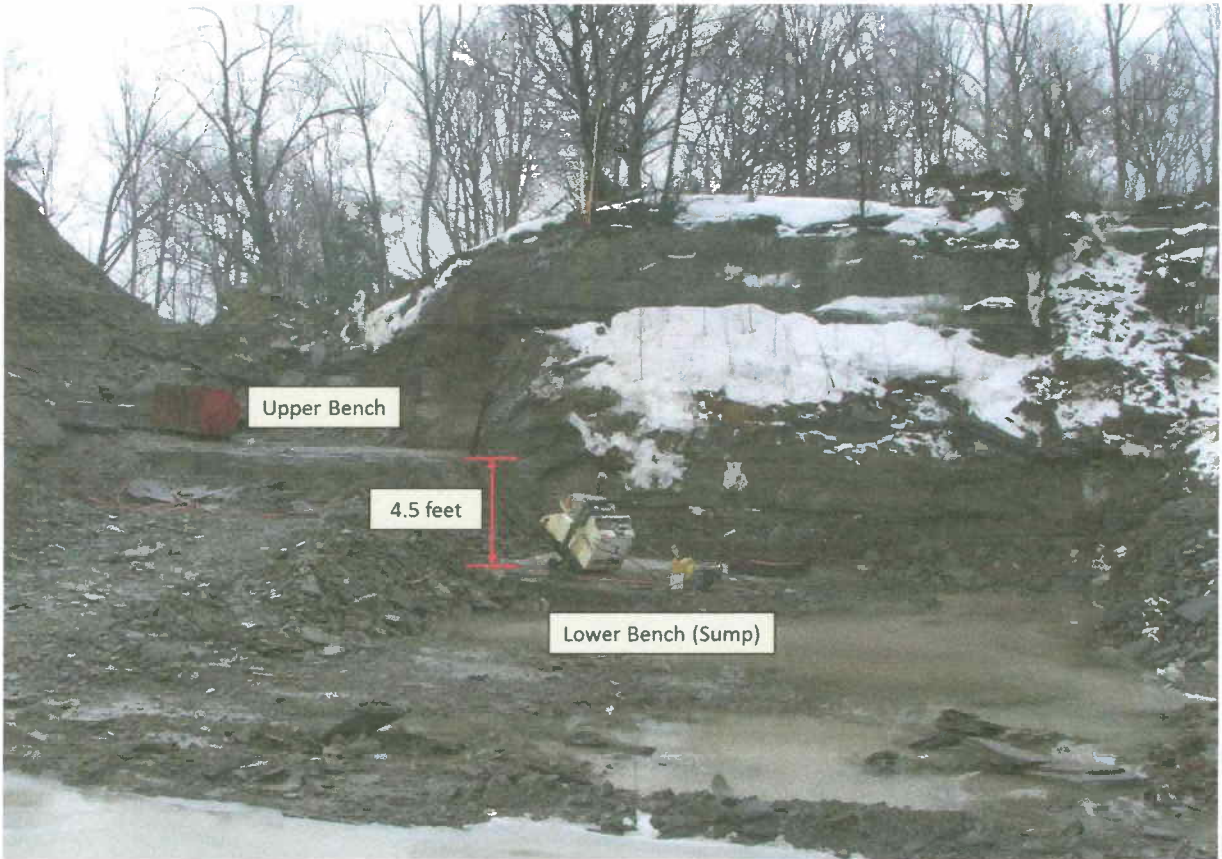
The accident occurred in the center of the quarry pit near the sump area (see Figure 1). A 25-foot-high waste pile of rocks is located to the east of the sump area, and the quarry access road and yard processing area are located to the west of the sump area. The sump area dimensions are approximately 40 feet wide by 80 feet long. Two benches had been created within the bluestone outcrop at the south end of the sump area. The upper bench is approximately 16 feet wide and the lower bench is approximately 18 feet wide. The high-wall above the upper bench is about 15 feet high and the high-wall above the lower bench is approximately 19½ feet high. Therefore, there is a 4½-foot height difference between the two benches. The exposed edge (drop-off) is oriented north to south and is approximately 10 feet long. The drop-off has a slope angle between 45 and 55 degrees. There is no berm or barrier installed along the edge of the upper bench.

Prior to the accident, the victim had made four north-to-south cuts and three west-to-east cuts along the upper bench. At the time of the accident, he was repositioning the saw for a fourth west-to-east cut across the bench. During this repositioning, with his back facing the edge, the victim slipped and fell onto the lower bench.

After the accident, the saw was found in the reverse gear, and the left handlebar was bent up slightly.

Root Cause: The victim failed to maintain control of the self-propelled concrete saw that he was operating in reverse gear while repositioning to cut stone. No procedures were in place for persons to safely operate the walk-behind, self-propelled concrete saw on an elevated bench.

Figure 1 – Victim was sawing stone blocks on the upper bench when he fell to the lower bench below (sump area) and the saw fell on top of him.

Corrective Action: The victim was a sole proprietor and; therefore, the business terminated at the time of his death. Consequently, no corrective action was taken.
