REPORT OF INVESTIGATION

Surface Nonmetal Mine
(Construction Sand and Gravel)

Fatal Powered Haulage Accident
March 8, 2016

Staker & Parsons Companies
Beck Street South
Salt Lake City, Salt Lake County, Utah
MSHA I.D. 42-00410

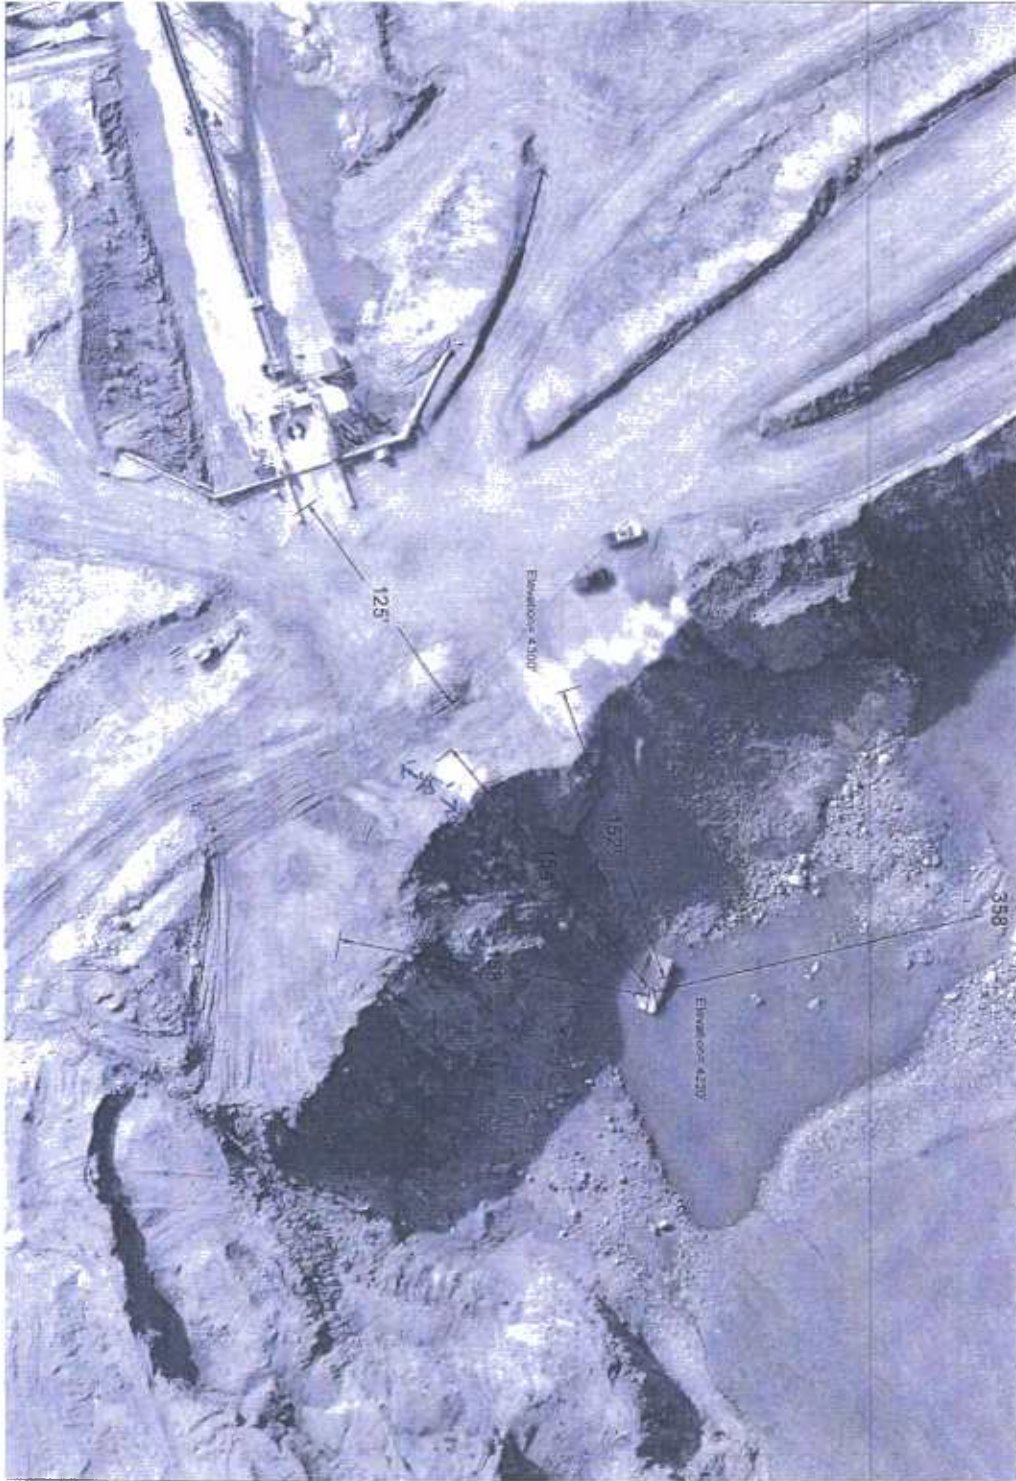
Figure 1 – Aerial Photograph of Accident Scene

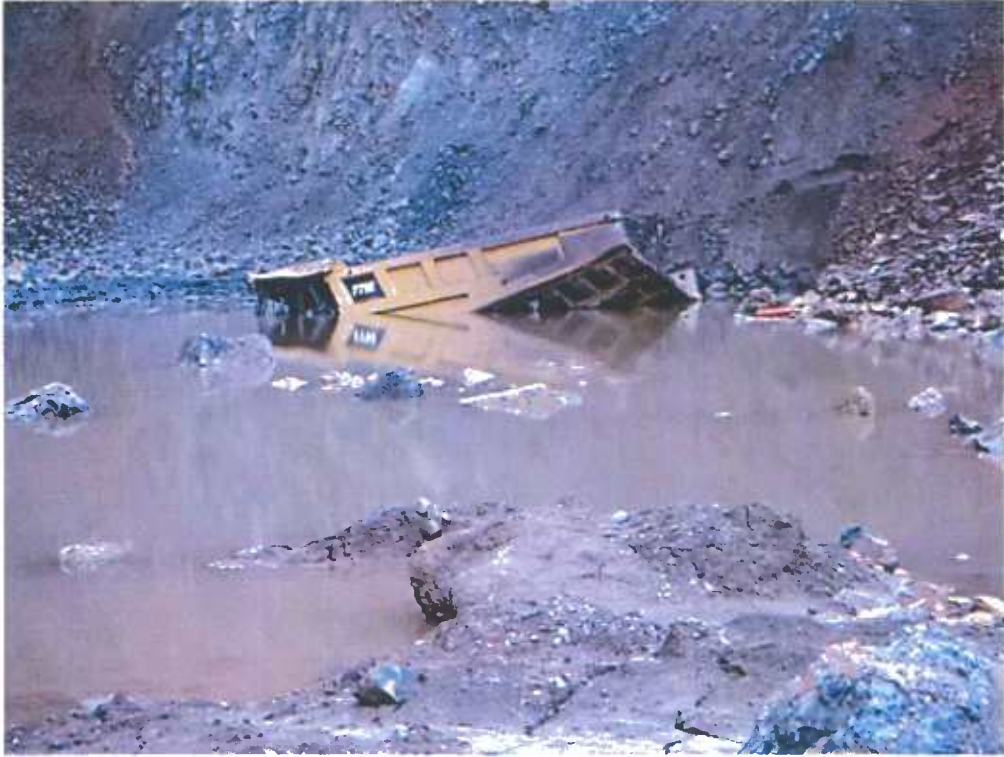
2. **Machine Damage:** The truck was under water from March 8, 2016 to March 23, 2016, while a road was built to allow recovery. After an initial inspection, the mud covering the truck was hosed off to allow further testing. The outside of the driver side door, on the left side of the truck, was damaged in the accident and was found open. It did not latch shut when attempts were made to close it. The inside and outside passenger side door handles functioned to open the passenger side door. The driver side window, windshield, and rear window were broken. There was little damage inside the operator's compartment and no cab deflection into the

operator's space. The left and right side mirrors, and the ladder and platform on the left side of the truck were visibly damaged. The backup light housings were half full of water. Subsequent testing showed that the electrical system was damaged. The engine was not operational due to the damage.

Figure 2 – Driver Side of Haul Truck

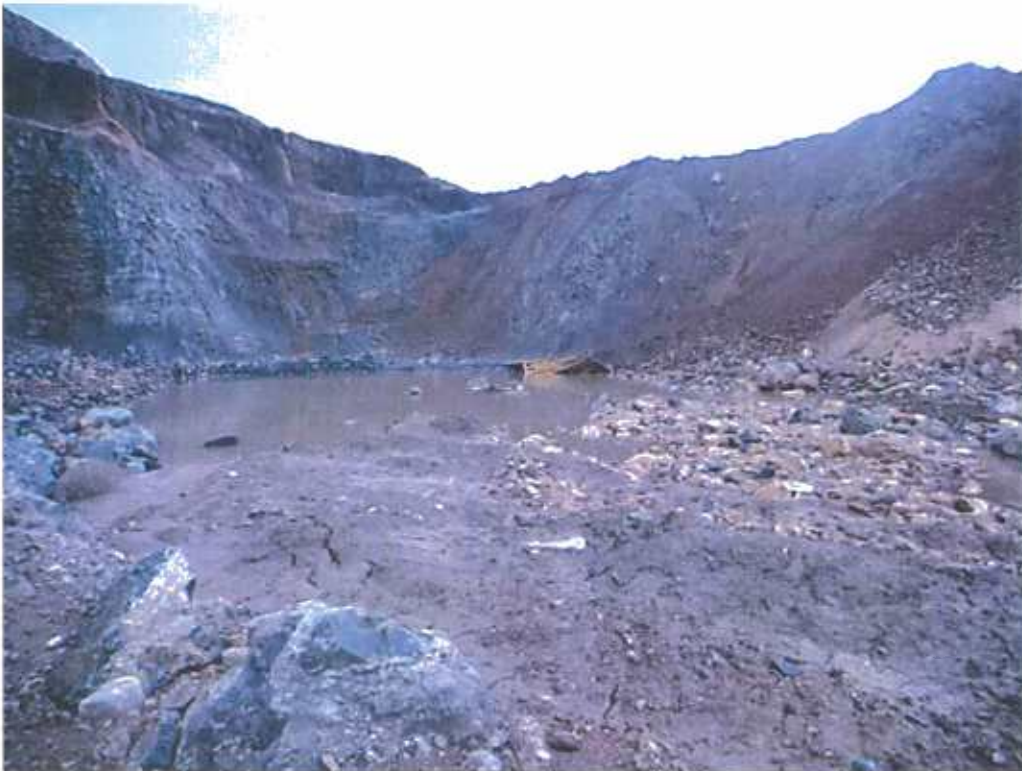
Figure 3 – Bottom of Dump Site Looking Up

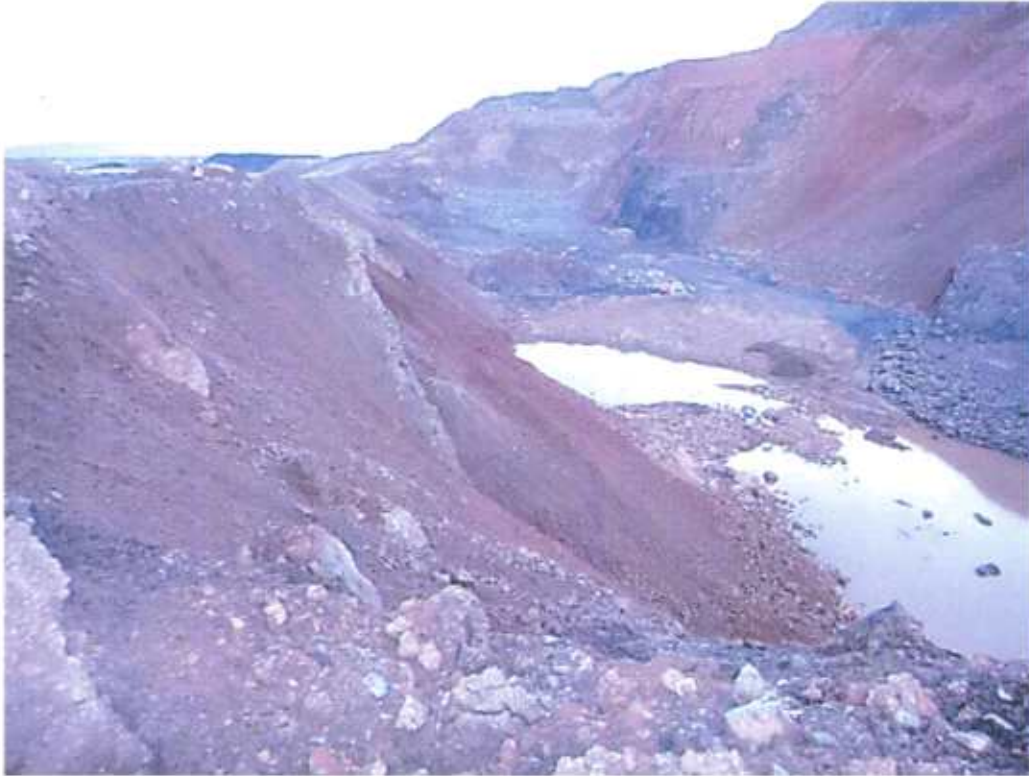
Figure 4 – Top of Dump Site Looking Down

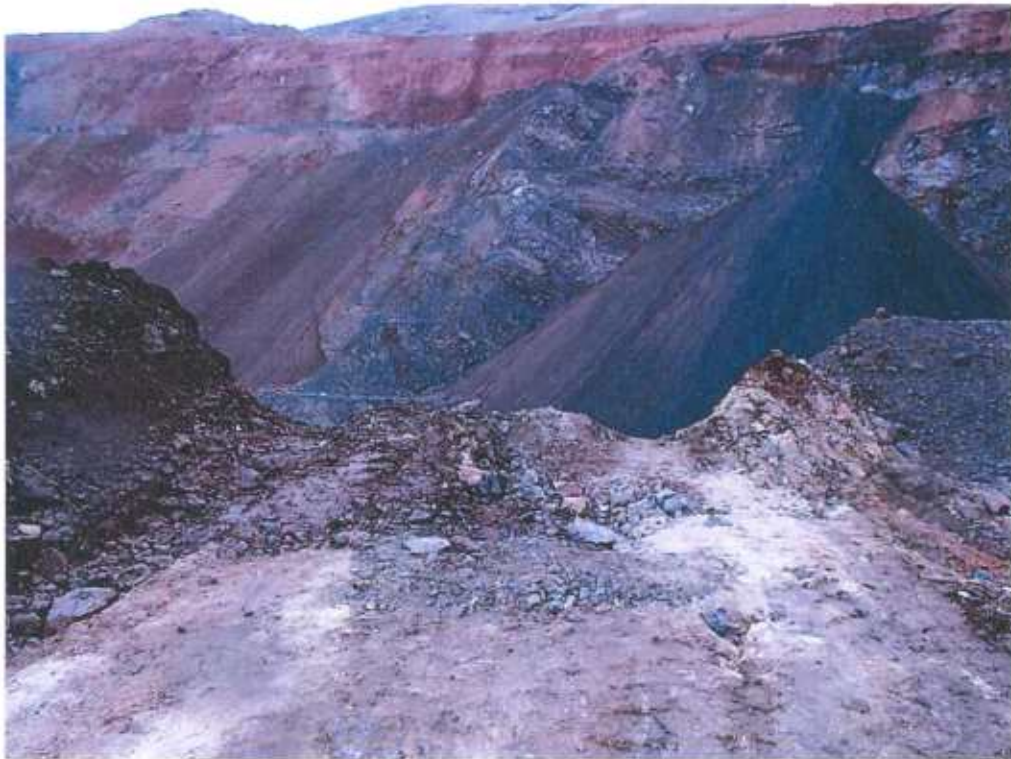
A fatal accident occurred at this operation on March 8, 2016 when an equipment operator operating a haul truck over travelled through a berm and off a dump site into a partially flooded pit. The equipment operator did not maintain control of the haul truck. There were no signs of evasive or corrective actions taken by the haul truck operator to maintain control of the haul truck.

Figure 5 – Dump Site Berm Where Haul Truck Travelled Thru

Corrective Actions: Management retrained all equipment operators in maintaining control of equipment while in operation.
