CHEMICAL LIME
COMPANY
BRIERFIELD QUARRY
Brierfield, Alabama

MAY 5, 2010

CRUSHED STONE FATALITY

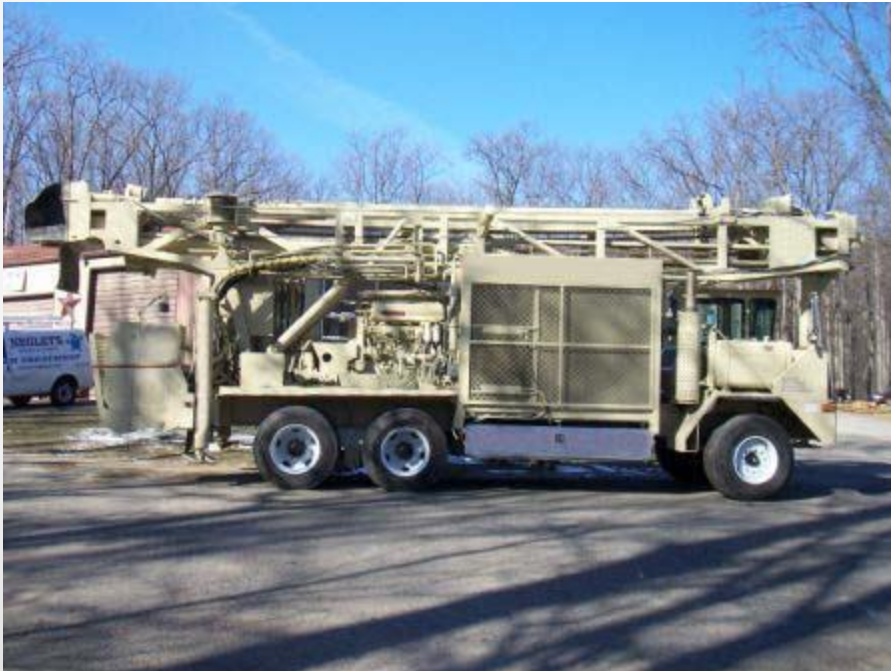
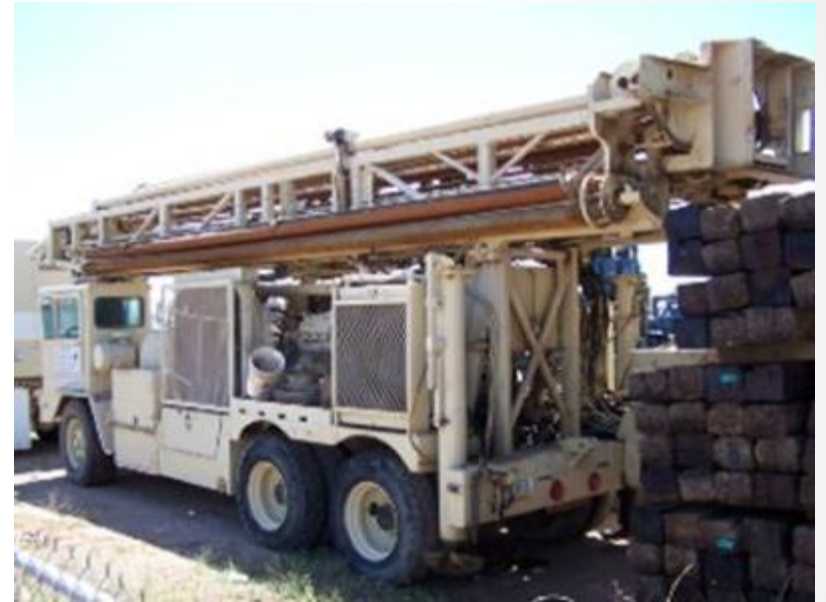
INGERSOLL RAND MODEL T4W WATER WELL DRILL

- A 21 year old contract driller with one year of experience was fatally injured.
- The victim was repositioning a truck mounted drill in a sloping work area of a quarry.
- He lowered the mast to the stored position.
- He had raised the two rear leveling jacks completely and had raised the single front leveling jack about 12 inches.
- The drill rolled over a small berm and into a small depression.

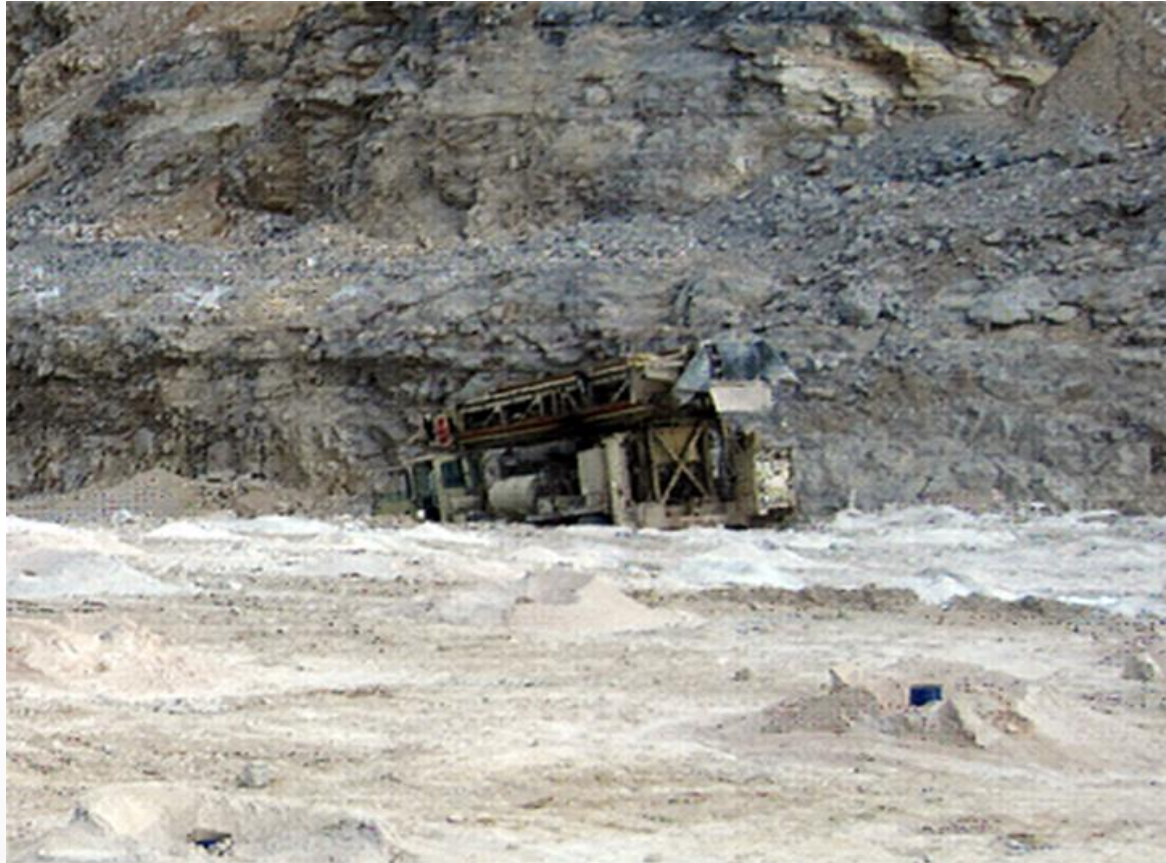
FINAL POSITION OF DRILL

- Investigators determined the victim sat on the edge of the operator seat with the cab door open and his head out of the cab.
- When the brake was released the machine was sitting on an 8.8% grade.
- The machine lunged forward dislodging the victim from the operator compartment.
- Due to the rough terrain the victim could not stay in the cab.
- He stayed with the machine for 109', fell out and the machine ran over him.
- The machine continued another 41' and stopped in a spoil area 10 feet lower than the drilling area.

- **Contractor management policies, procedures, and controls were inadequate and failed to ensure that operators could safely move the drill from one hole to the next hole to be drilled.**
- **Contractor management failed to properly task train drill operators in the safe operation of the rubber tired drill.**

- **Assure miners are properly task trained in equipment operation.**
- **Use seat belts at all times in mobile equipment.**
- **Use mirrors to position equipment.**
- **Stay in cab of equipment.**
- **Use a spotter to assist operator in positioning equipment.**
- **Assure brakes on mobile equipment are sufficient to hold on maximum grade worked.**
- **Assure terrain is compatible with equipment.**
