Green Brothers Gravel Company Harmony Mine & Mill

Fatal Accident: June 3, 2016

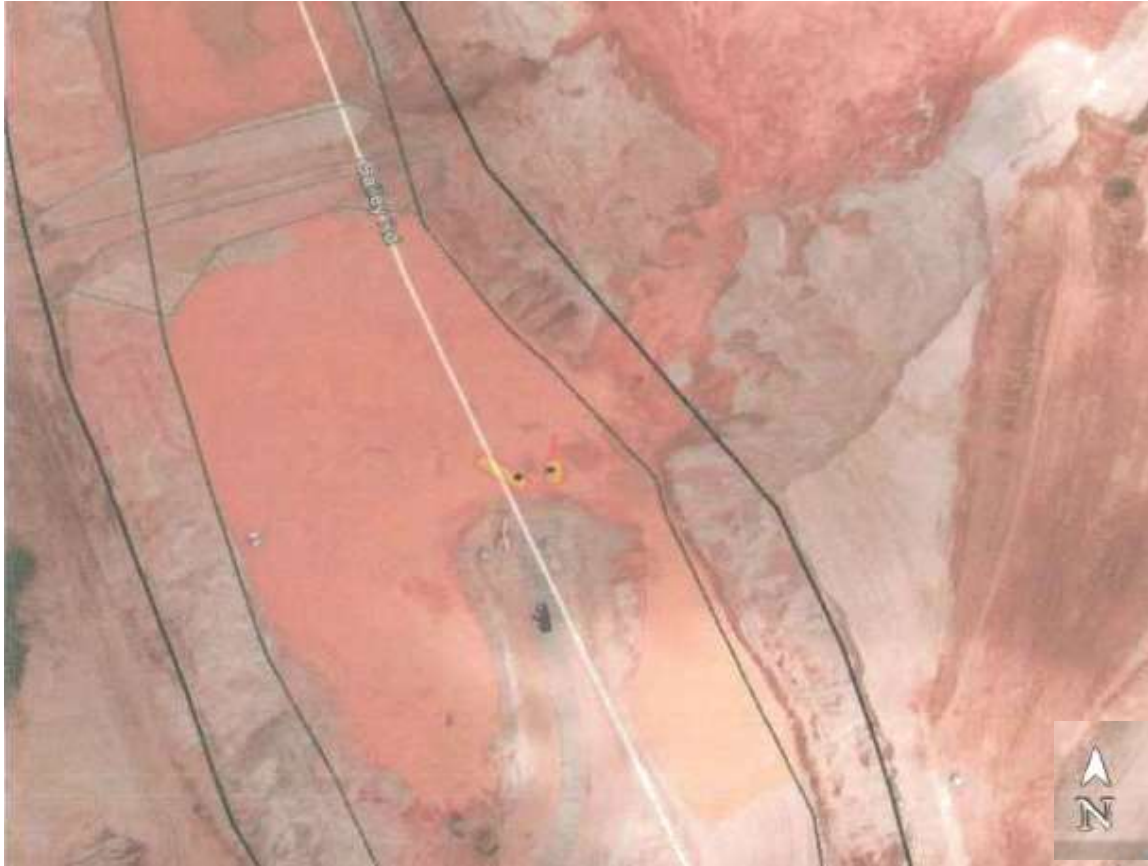
- June 3, 2016 James “Dee” Hemphill, Dirt Crew Supervisor (age 56), and Emmitt Shorter, Haul Truck Driver (age 24) were killed when they were engulfed with slurry.
- Hemphill was loading Shorter’s truck with an excavator about 50 feet west of the Johnson Pit wall.
- The pit wall failed and inundated the pit with liquefied slurry, engulfing the two miners.

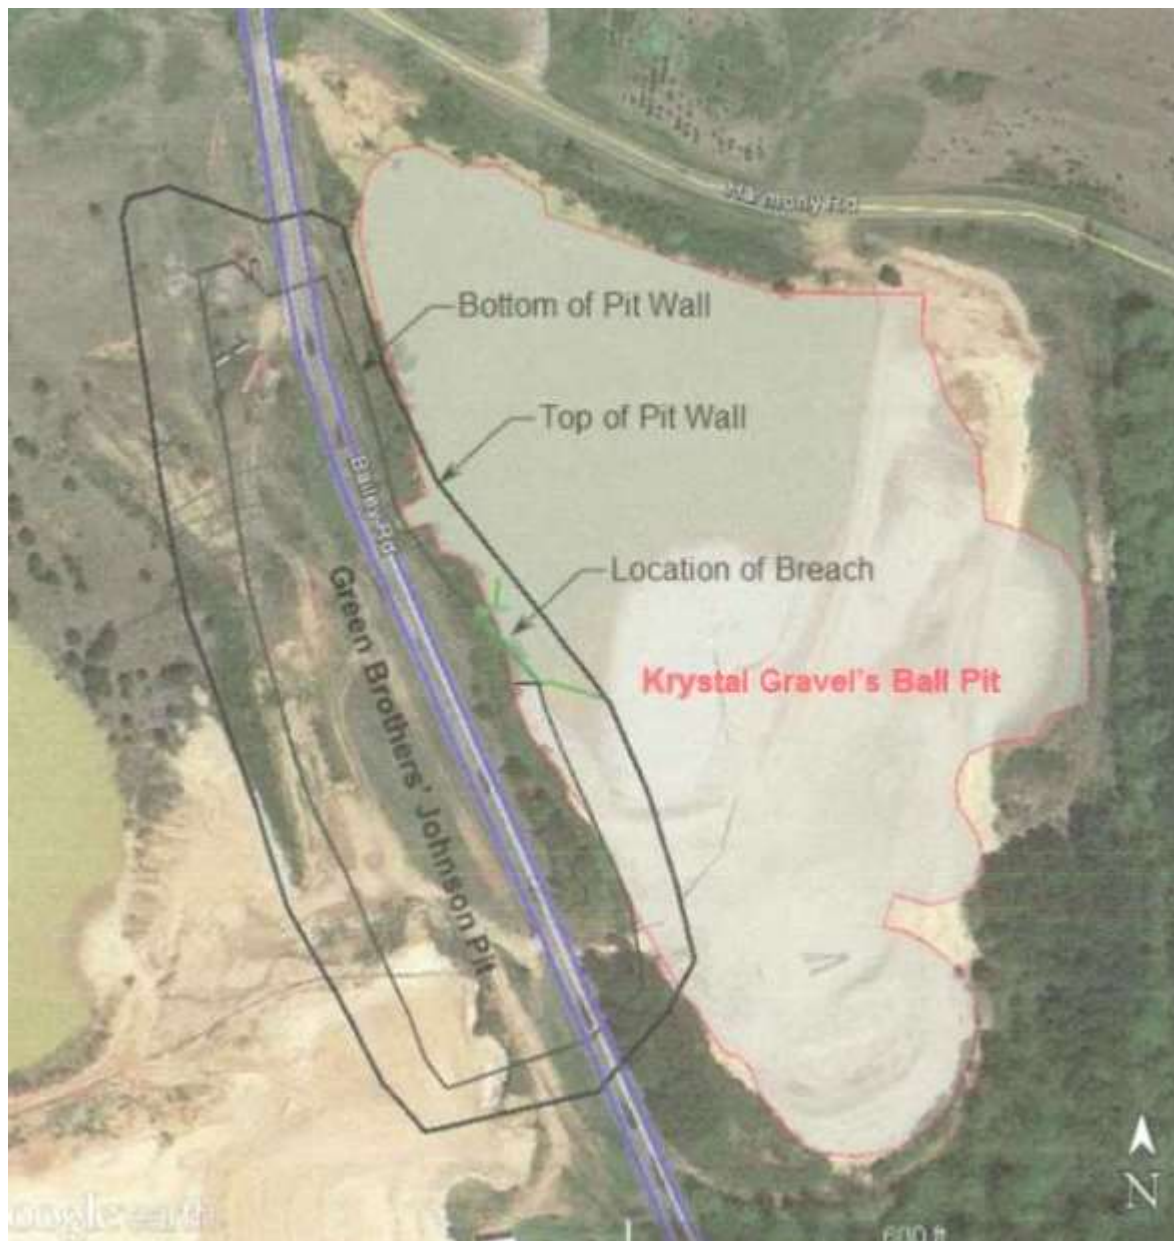
The excavator was positioned near the east pit wall facing a northern direction at the time of the failure. The truck was on the west side of the excavator, and was facing south to southeast.
