REPORT OF INVESTIGATION  
Underground Coal Mine

FALL OF ROOF/RIB  
June 16, 2010

Clover Fork No. 1  
Lone Mountain Processing Inc.  
Holmes Mill, Harlan County, Kentucky  
ID No. 15-18647

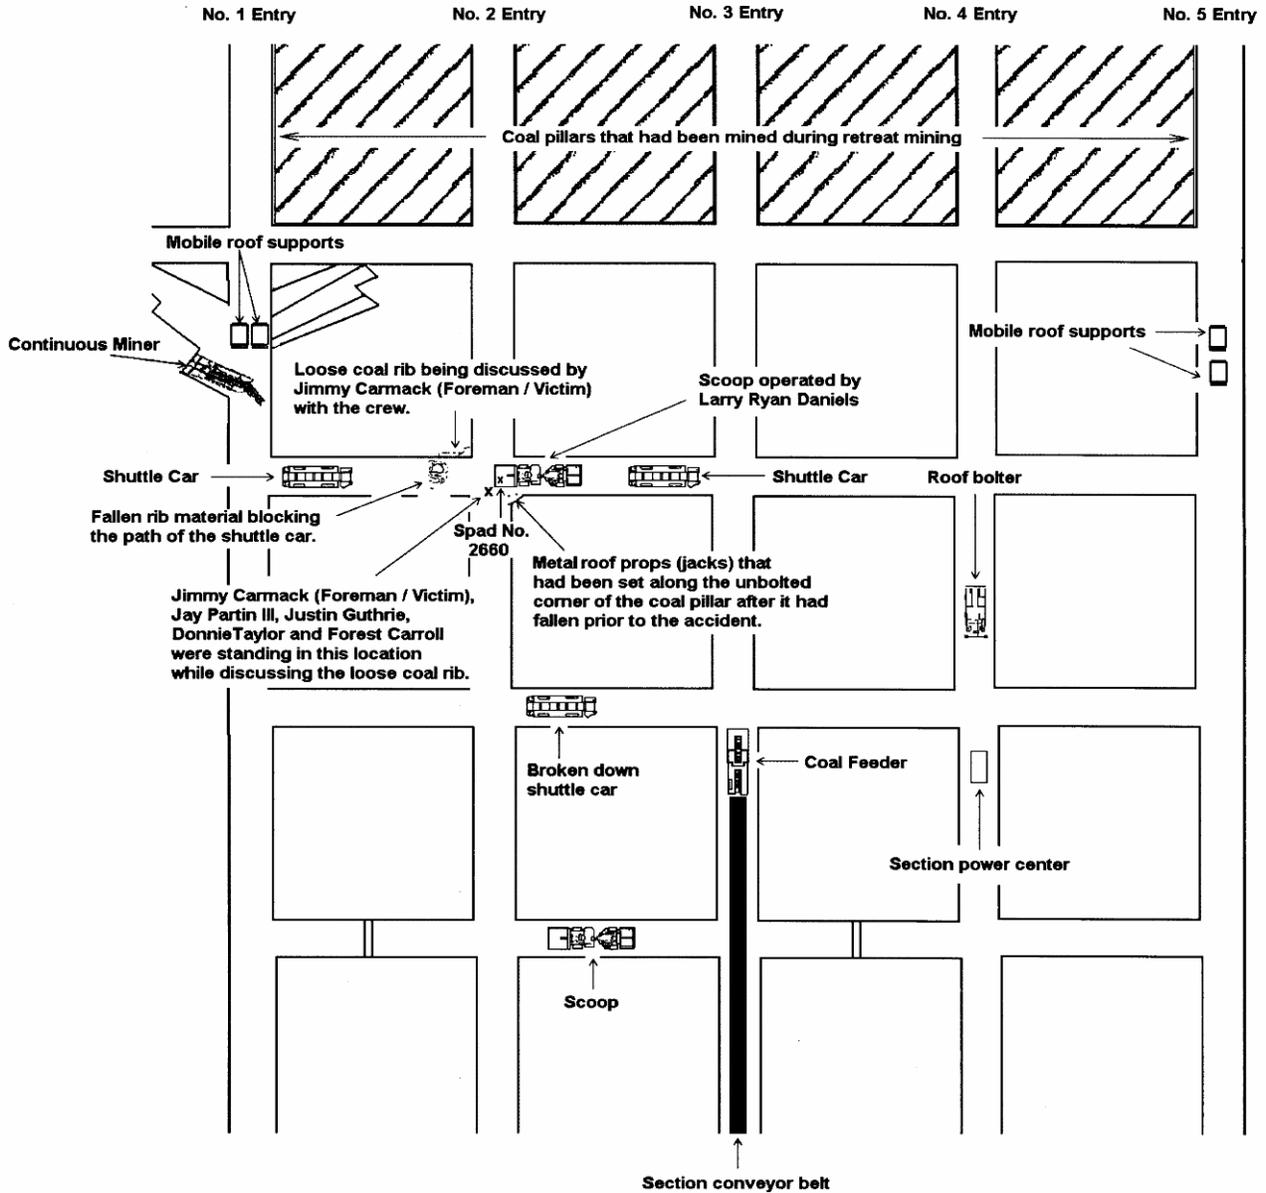
Sketch No. 1  
Before The Accident  
Not To Scale

The rib of the right outby corner at survey station No. 2660 had fallen out prior to the accident and three Heintzmann 50-ton roof jacks were installed to limit excess intersection width caused by the fallen rib.

## 001 Section The Accident Scene - No. 2 Entry

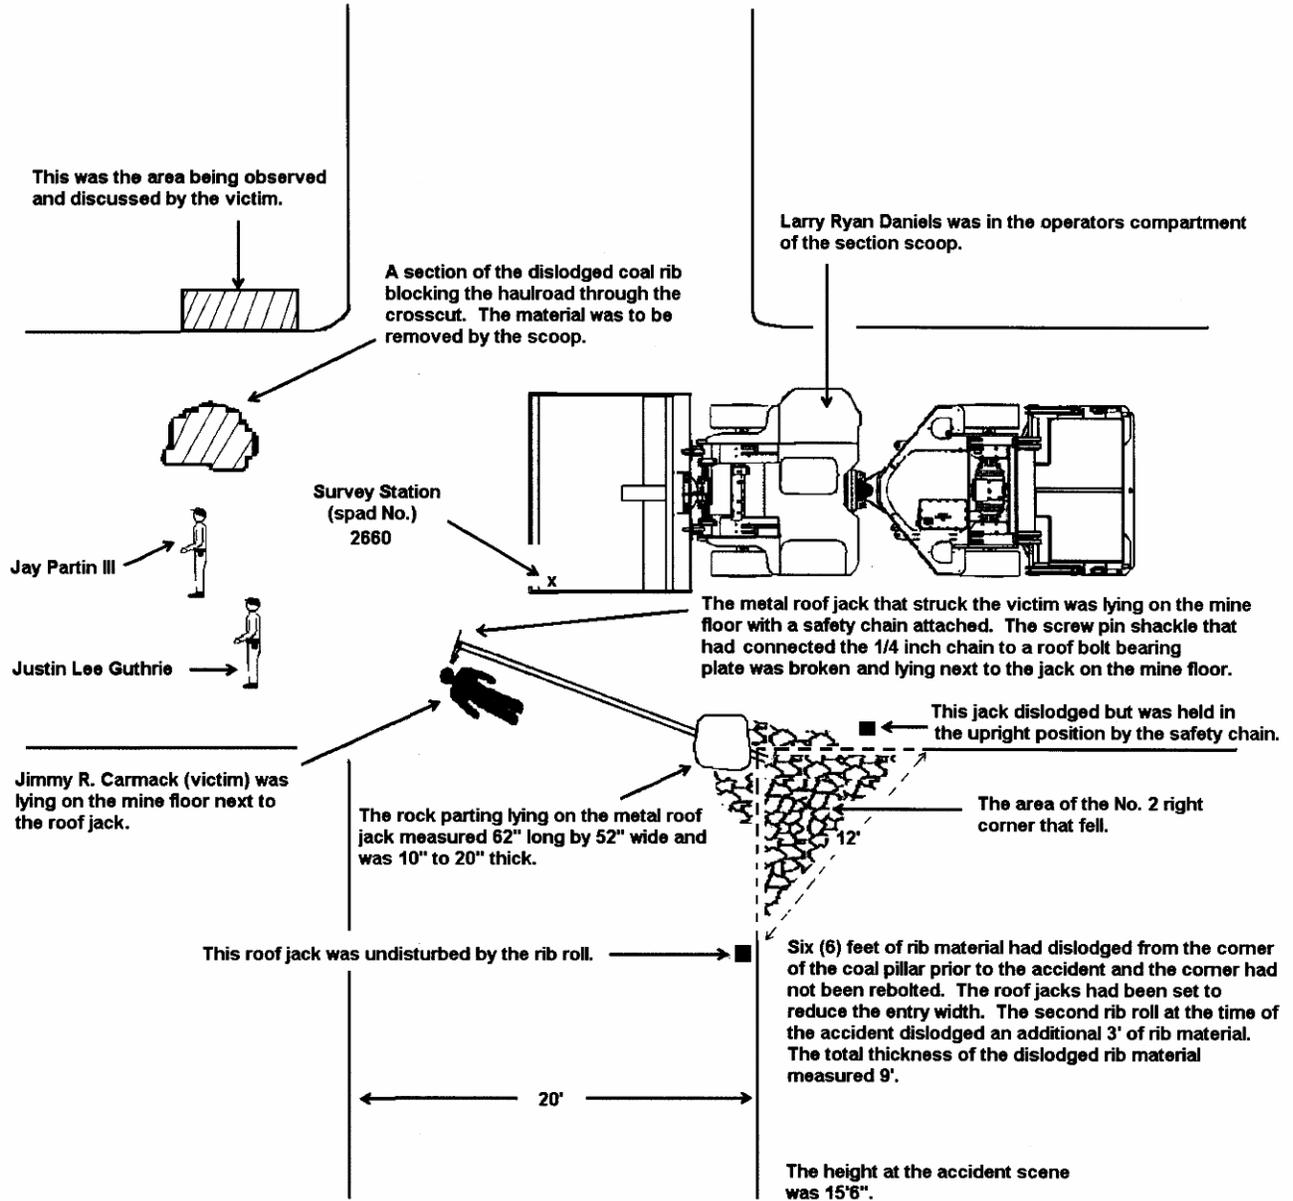
**Sketch No. 2  
After The Accident  
Not To Scale**

During the accident, two of the Heintzmann jacks were dislodged by the falling rib. The metal bearing plate on top of one of the jacks (approximately 8 inches by 8 inches and 3/8 inches thick) struck Carmack in the head. The top of the jack had been attached to a roof bolt bearing plate with a chain and a 1/4 inch clevis. The clevis broke, allowing the jack to fall and strike the victim.

A portion of the rock parting (separation) between the two coal seams came to rest on the fallen jack. This piece of rock measured approximately 62 inches in length, by 52 inches wide, and varied in thickness from 10 inches, up to twenty 20 inches.

**001 Section  
The Accident Scene - No. 2 Entry**

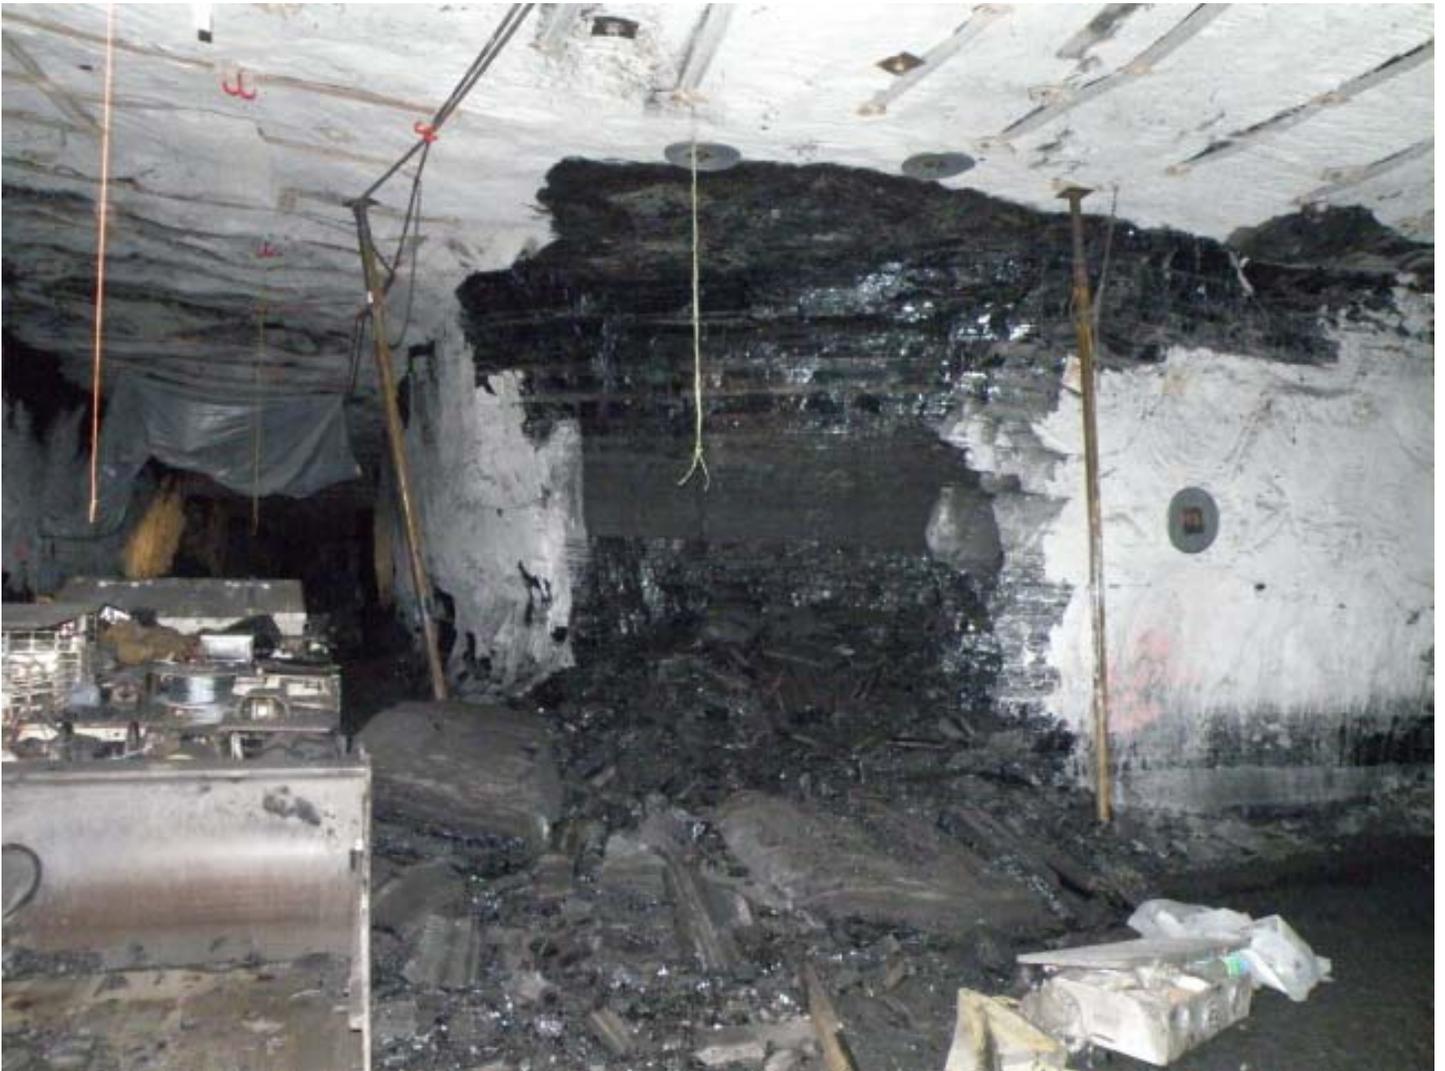
**Appendix D**  
**Photograph of Accident Scene**

Carmack was standing in the intersection of the No. 2 Entry discussing corrective measures for the area of fallen rib material, located at the left inby corner rib, with crew members: Guthrie; Partin; Donnie Taylor, Shuttle Car Operator; Daniels; and Forest Evan Carroll, Shuttle Car Operator. During their discussion, the right outby rib corner fell, dislodging two large Heintzmann roof jacks. One of the dislodged jacks struck Carmack in the head, causing fatal injuries.
