REPORT OF INVESTIGATION

**Fatal Powered Haulage Accident
January 2, 2010**

**Bull Mountains Mine No. 1
Signal Peak Energy LLC
Roundup, Musselshell County, Montana
MSHA I.D. No. 24-01950**

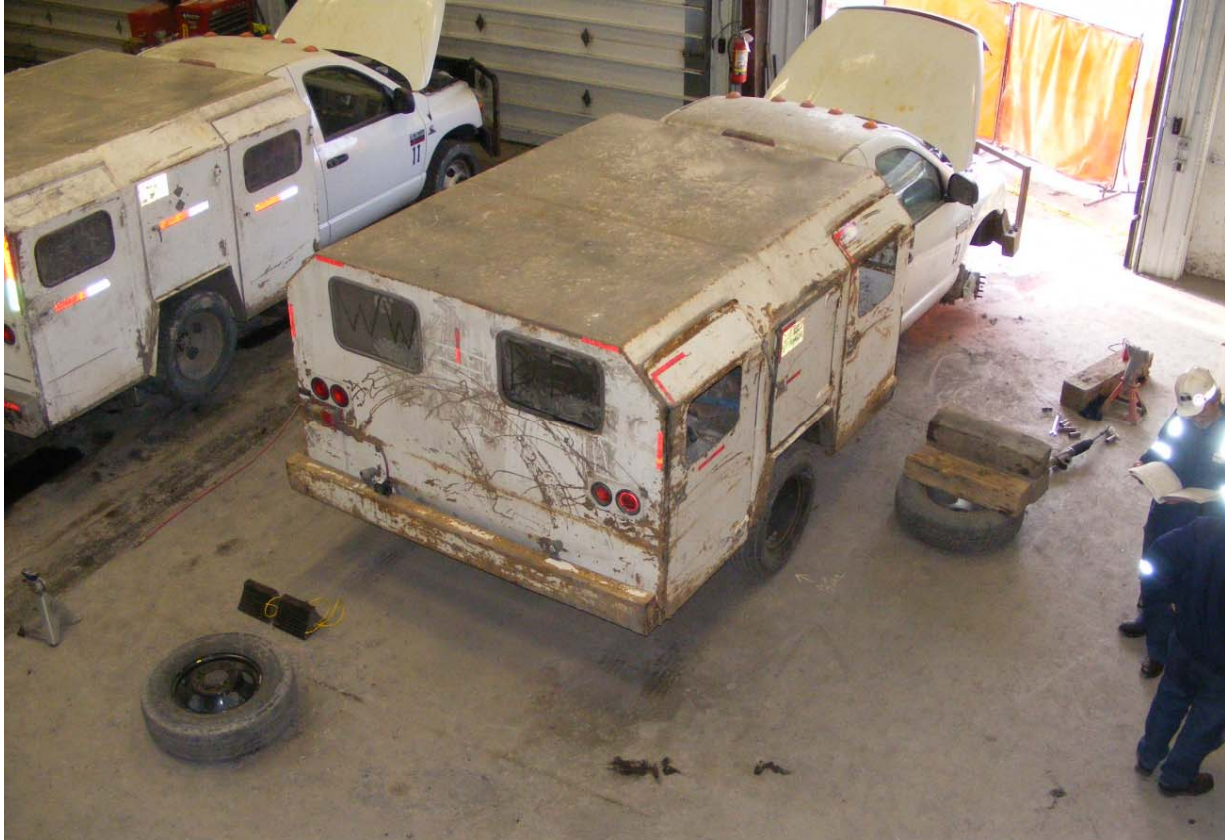
VIEW OF ACCIDENT SCENE

TRUCK WITH FABRICATED MANTRIP COMPARTMENT

Skid marks from the front brake assemblies contacting the mine floor indicate that the truck moved forward approximately 6 to 6.5 feet after it fell off the jack stands. After the accident, the truck was approximately 18 inches from the shop door. Prior to the accident, the truck was approximately 93 inches from the door. The truck was not securely blocked/chocked against motion. Evidence at the scene indicated that the park brake on the truck was not engaged at the time of the accident.

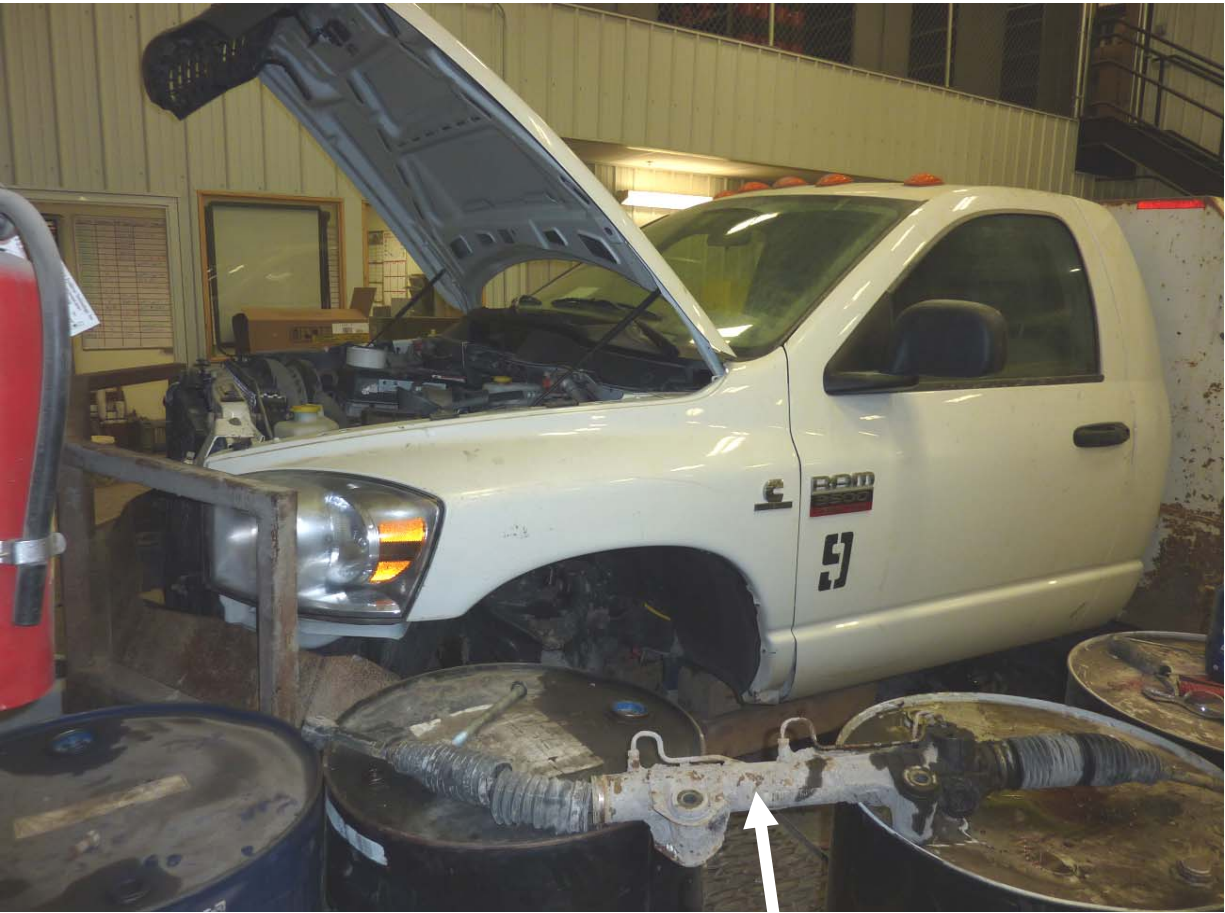
View of Truck and Power Steering Unit

POWER STEERING UNIT TAKEN OFF TRUCK

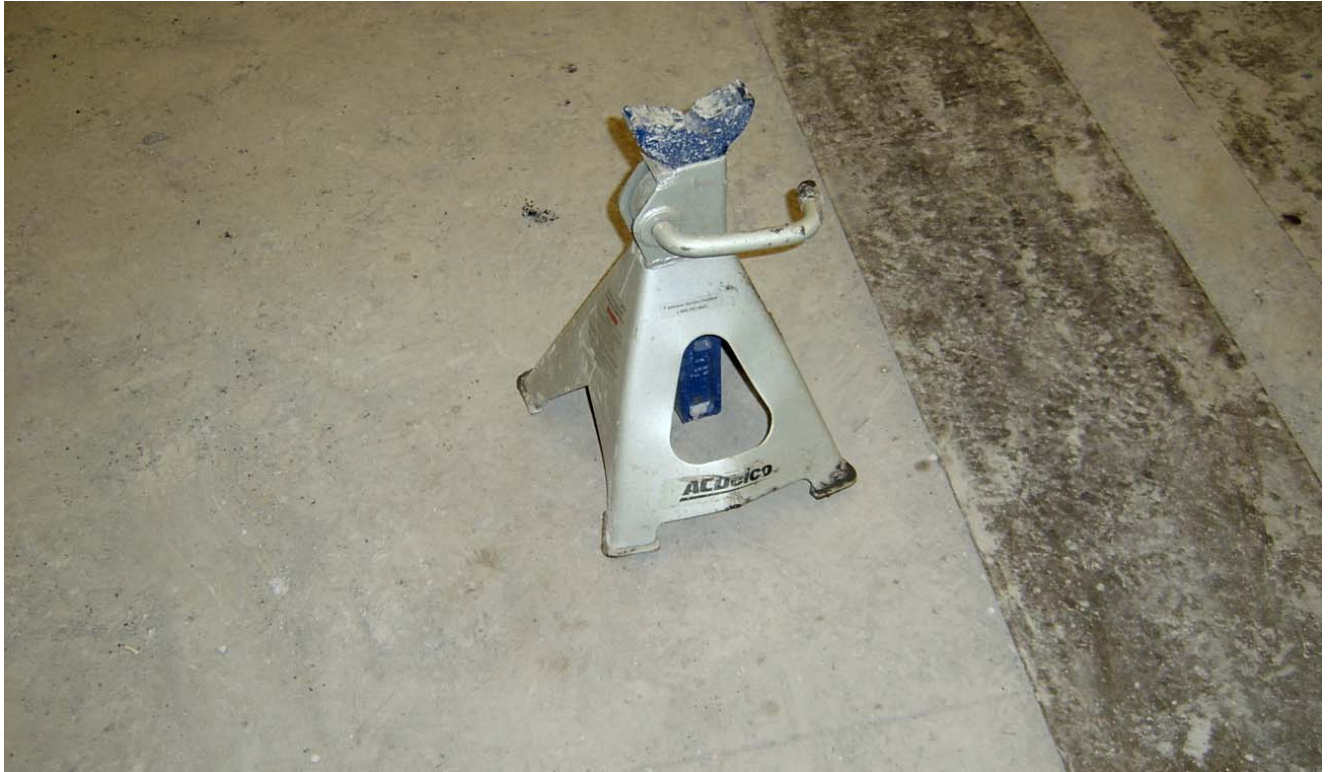
View of AC Delco Jack Stand

When the accident occurred, the front wheels had been removed from the truck and the front end was supported with two 6-ton AC Delco jack stands. At the end of dayshift, the mechanics left the front of the truck up on the two jack stands and had placed a heavy duty floor jack under the front bumper. The floor jack was not in place at the time of the accident. The two 6-ton AC Delco jack stands were considered adequate to support the truck in an elevated position, as long as the engine and drive wheels were not engaged.

Corrective Action: On January 5, 2010, the mine operator implemented procedures titled “Supporting Elevated Equipment” for the safe support of raised equipment when work is done under such equipment. Item 3.C. requires equipment to be blocked against movement using suitable chocks at wheels, tracks, etc. and that parking brakes and transmission locks be used

where applicable. Item 7.A. states that no work will be done on equipment while the engine is running, unless all drive wheels, tracks, etc. are off the ground. All affected miners were trained in the new procedures for “Supporting Elevated Equipment.” Signal Peak Energy purchased a 4-post runway 18,000 pound lift with a 68-inch rise for use in the surface shop to support raised equipment safely when work is done under the equipment.

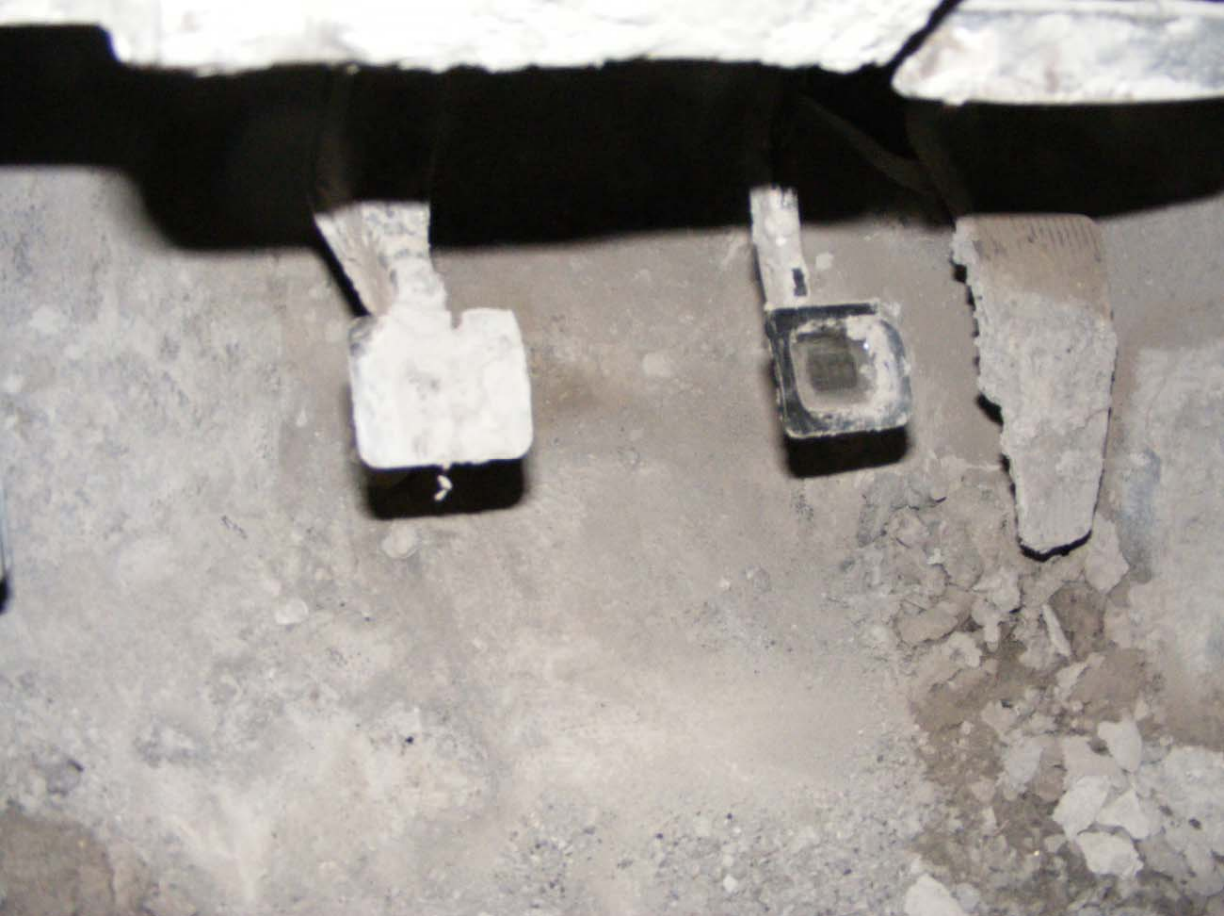
View of Clutch Pedal (left) and Brake Pedal (right)

The clutch pedal was examined during the investigation and the rubber friction pad/anti-slip cover for the top of the clutch pedal was missing, exposing the metal of the clutch pedal. The pedal had mud on it when it was examined, indicating that the cover was missing prior to the accident. The rubber friction pad/anti-slip cover for the top of the brake pedal was not on the pedal, but was found on the floor of the truck. It appeared that this cover was dislodged by Demers when he depressed the brake pedal with force after the truck started to lurch forward. The brake pedal was clean, indicating that the cover had been in place prior to the accident. See Appendix D for a picture of the clutch and brake pedals. Demers was wearing leather boots with rubber soles. He had worked in the wash bay earlier in the shift, washing mud off vehicles, but could not say whether his boots were wet/muddy at the time of the accident. He did state that “you are always wet and muddy when working at the mine.”

Root Cause: Management did not maintain the truck in safe condition in that the rubber friction pad/anti-slip cover for the top of the clutch pedal was missing. This unsafe condition contributed to the assistant’s foot slipping off the depressed clutch pedal, causing the accident.

Corrective Action: The rubber friction pad/anti-slip cover for the clutch pedal was replaced and training was provided to equipment operators to check for such safety defects during pre-operational inspections.
