Martin Marietta Materials Plant 862

Fatal Accident: March 22, 2016

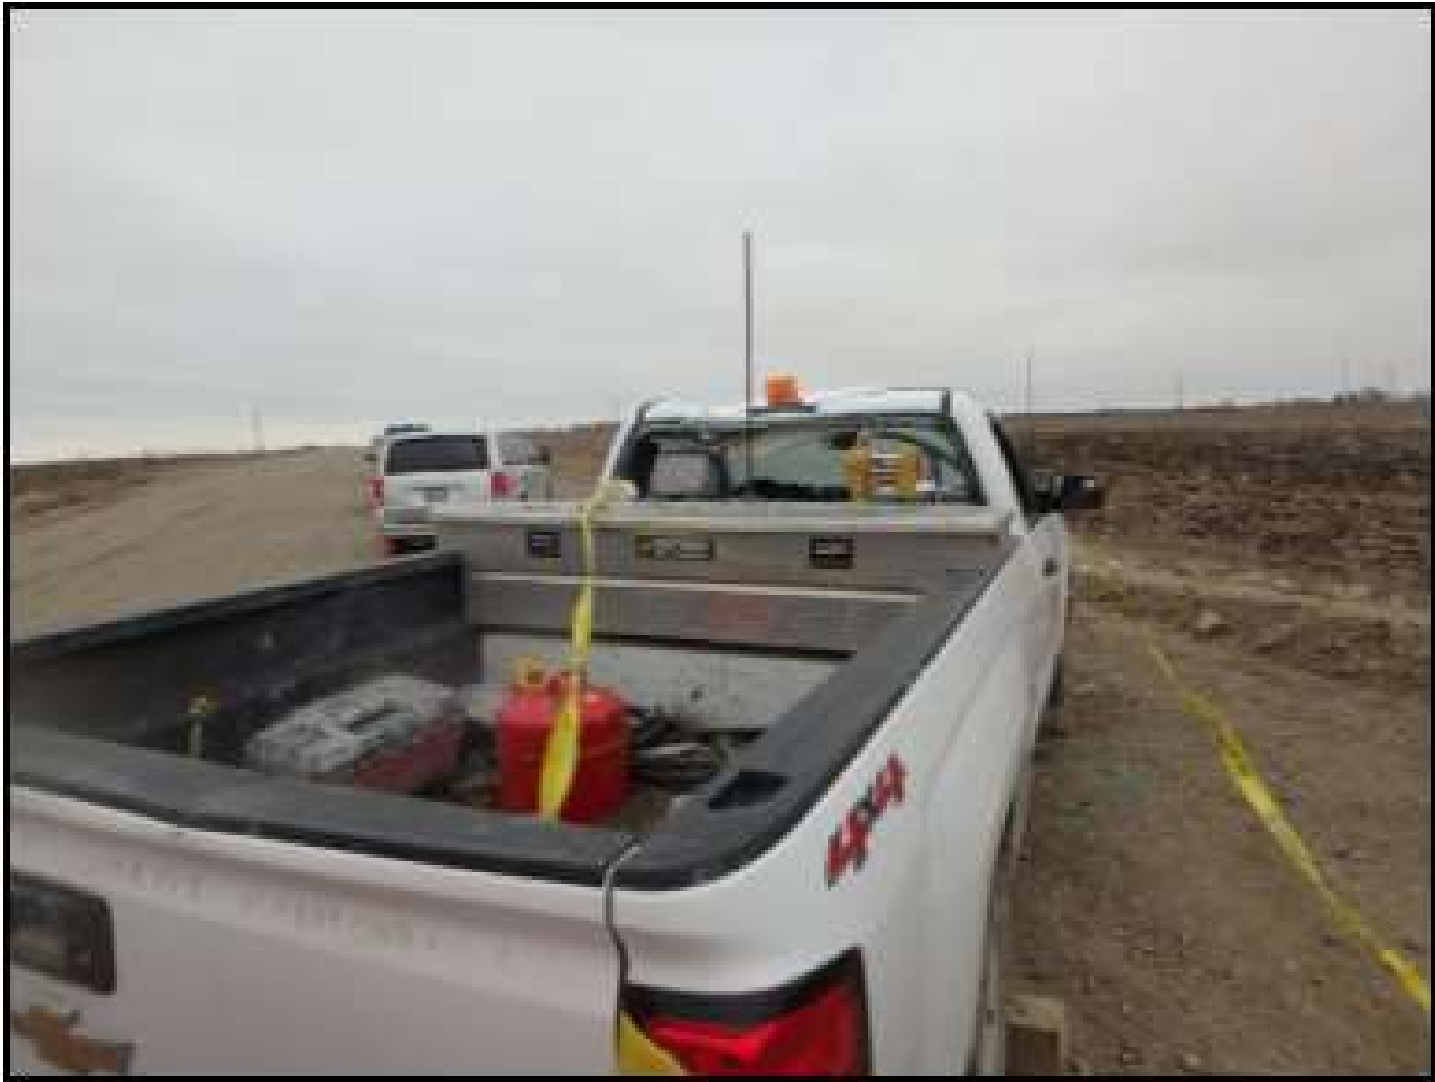
- March 22, 2016 Tracy L. Hockemeier, Leadman, age 42 was fatally injured when he was struck by fly rock
- He was sitting in his pickup truck, about 1,200 feet from the blast site
- At blast initiation, fly rock was propelled upward, landing on and penetrating the roof of the truck and striking the victim
