REPORT OF INVESTIGATION

Fatal Fall of Person Accident
June 12, 2010

MOR-PPM, Inc.
Contractor ID G908
at
Unimin Minnesota Corporation
Ottawa Pit and Plant
Le Sueur, Le Sueur County, Minnesota
Mine ID No. 21-00790

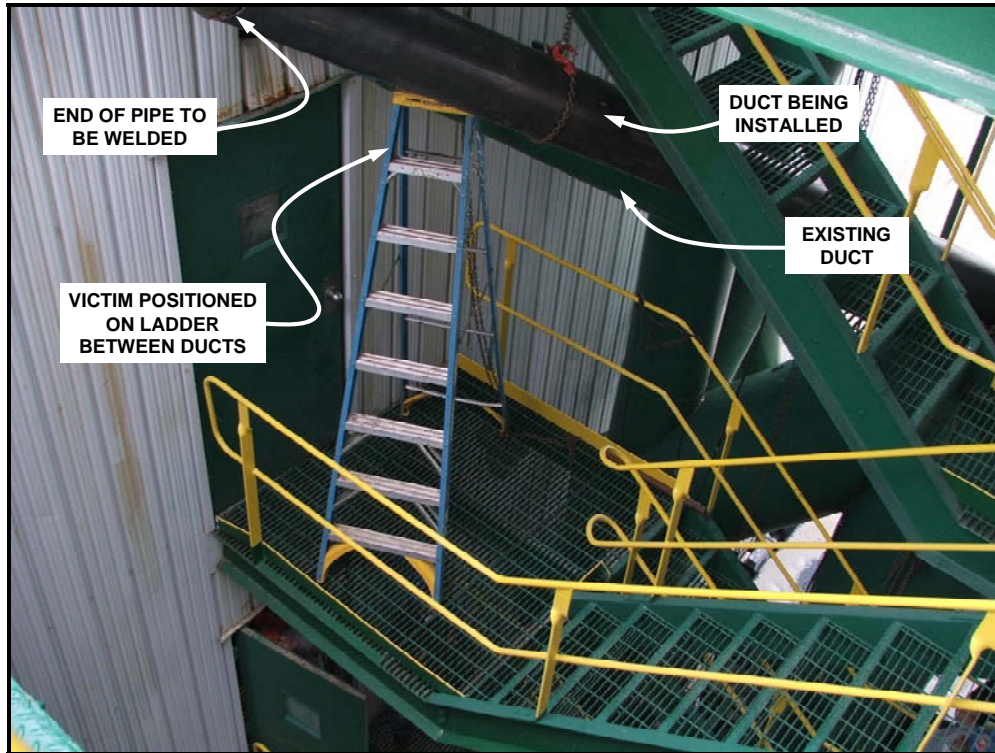
Figure 1 – Work area location

The accident occurred on a stairway landing (Figure 1) on the exterior of the load out building. The ladder was positioned between an existing ventilation duct and another ventilation duct that was being installed (Figure 2). The elevation of the ducts placed the centerline of the existing duct at the same elevation as the top of the ladder. The duct being installed was located slightly higher and about 34 inches from the existing duct.
