**ST&T Leasing, Inc. (ZJD)  
at  
No. 11 Allen Branch Job  
Apex Energy, Inc.**

Fatal Accident: May 28, 2015

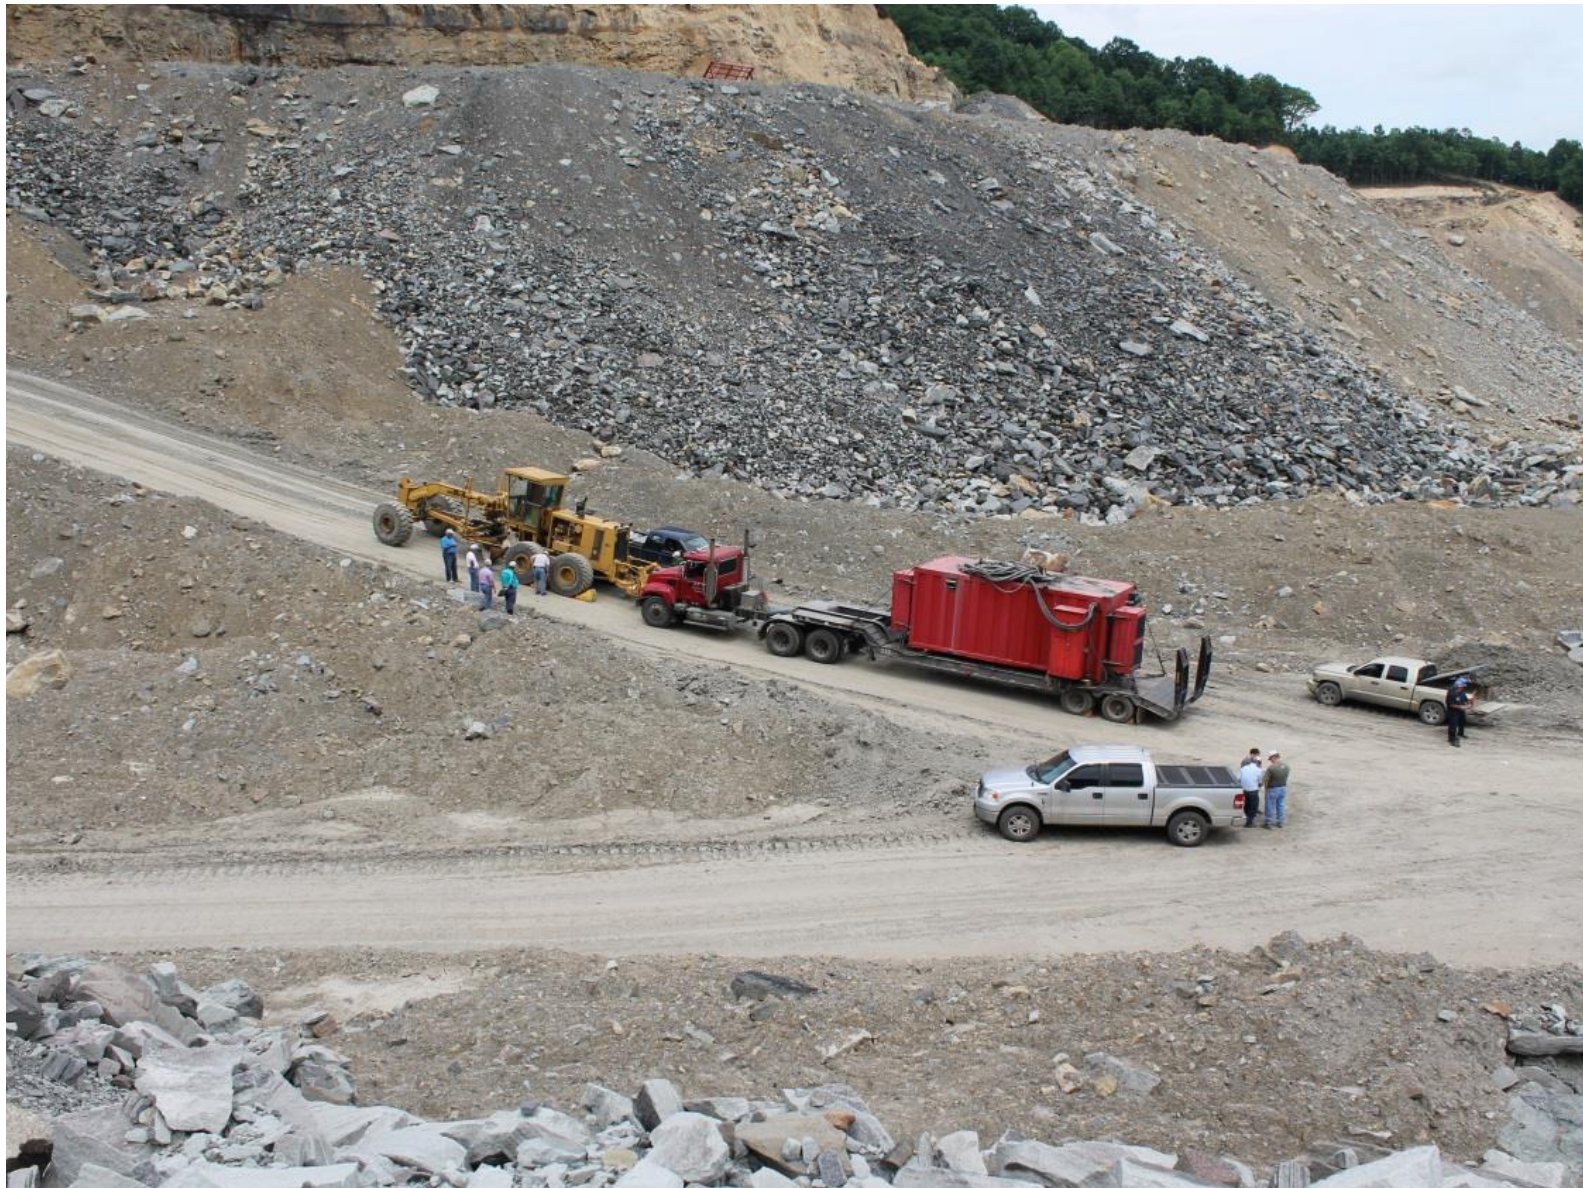
- May 28, 2015 Roy Mullins, foreman, age 45 was killed when he was pinned between the frame of a road grader and the front of a loaded tractor-trailer truck.
- The tractor-trailer was transporting the base power module of a highwall mining machine to the mine site.
- The tractor-trailer was unable to ascend the steep incline.

- A road grader was driven to the tractor-trailer to provide assistance.
- Mullins was positioned between the two machines connecting a chain.
- The grader rolled back, fatally crushing him.

- Never position yourself between equipment that is not blocked and secured from movement.
- Turn the engine off, place the transmission in gear, set the parking brake, and always ensure equipment is securely blocked against motion, before performing repair or maintenance work, which includes connecting tow bars.

- Maintain equipment braking systems in good repair and adjustment. Do not depend on hydraulic systems to hold mobile equipment stationary.
- Conduct pre-operational examinations to identify and repair defects that may affect the safe operation of equipment before it is placed into service.

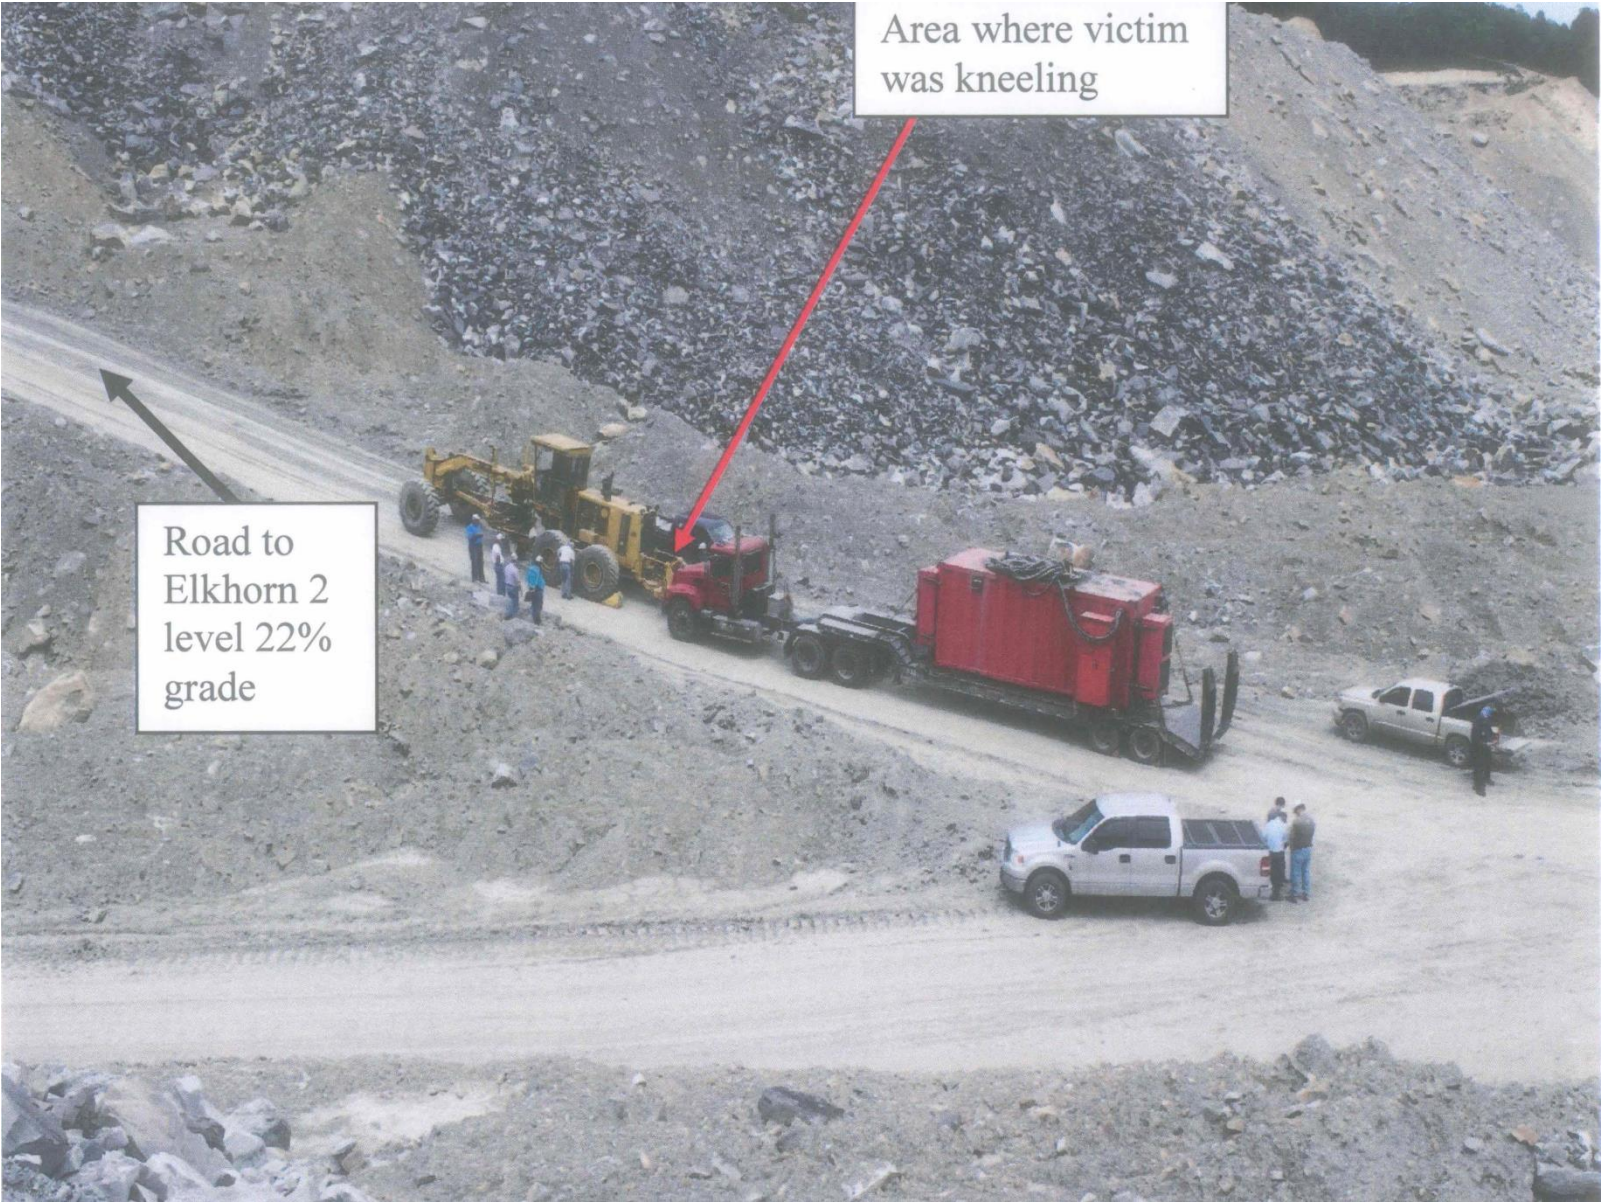
- The road was not properly designed to have a grade that could be travelled by the tractor-trailer carrying the base power module.
- The mine operator failed to adequately train all mine employees in proper towing procedures.

Area where victim was kneeling

Road to Elkhorn 2 level 22% grade

The mine operator failed to establish policies and procedures to ensure access roads are designed and maintained to allow mobile equipment operators to travel roadways without being towed.

The policies and procedures of the mine operator were inadequate to ensure that proper towing procedures and equipment were in place when towing became necessary.
