Luck Stone Corp – Leesburg Leesburg Plant

Fatal Accident: August 3, 2015

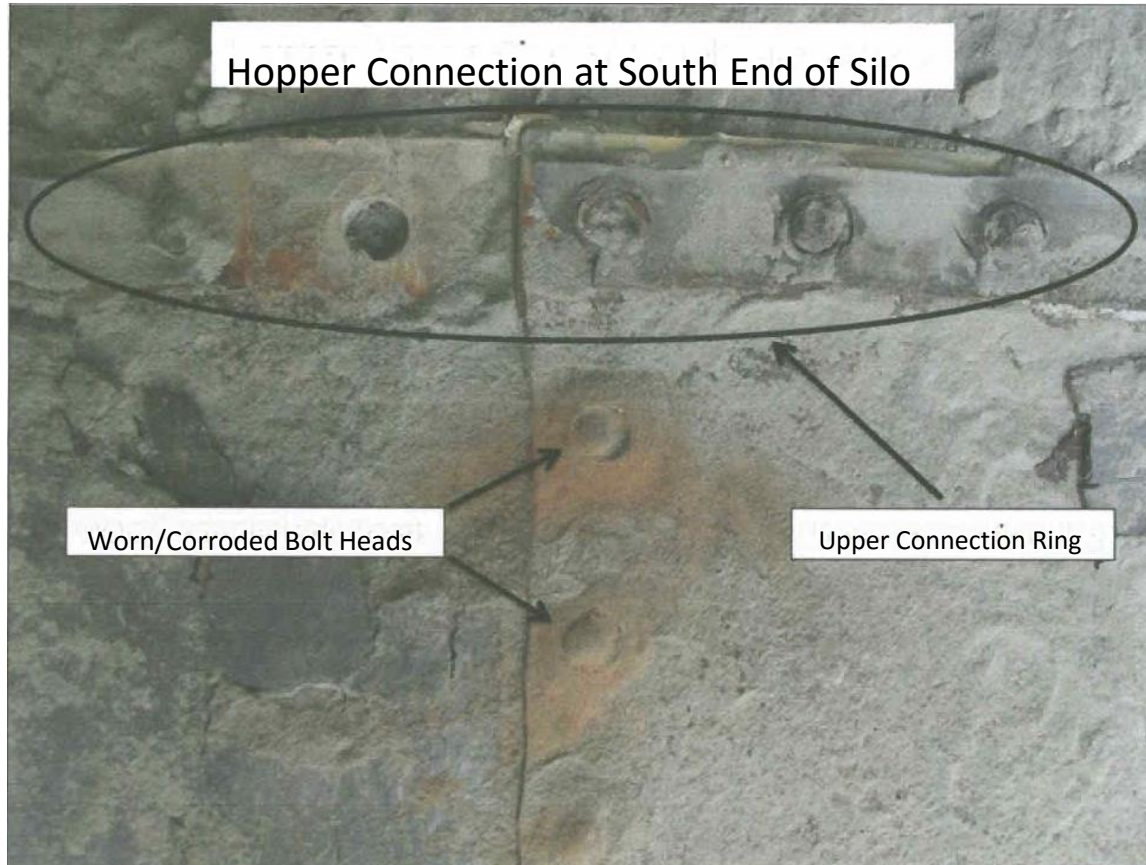
Photo showing interior of "Sand Plant Fines" Silo
