# Kane's Quarry (Dimension Sandstone)

Fatal Accident: March 23, 2015

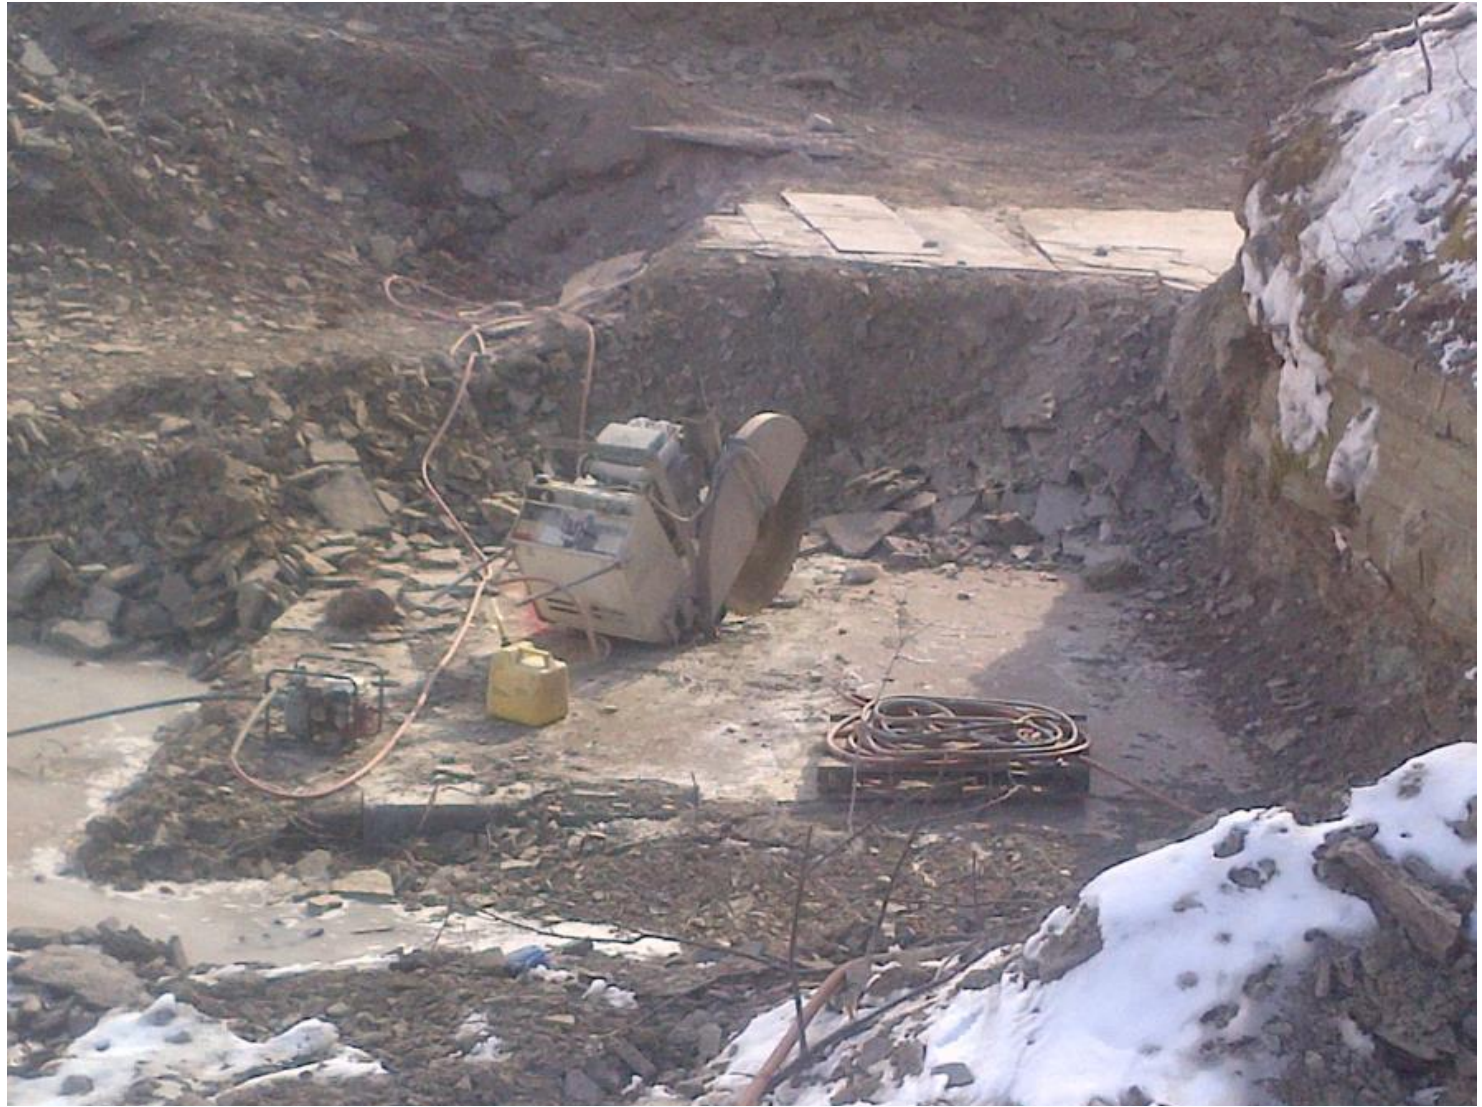
- Daniel Acker was positioned between the saw and the ledge, when he tripped and fell.
- He and the saw went over the 4 ½ foot ledge.
- The saw fell on him.

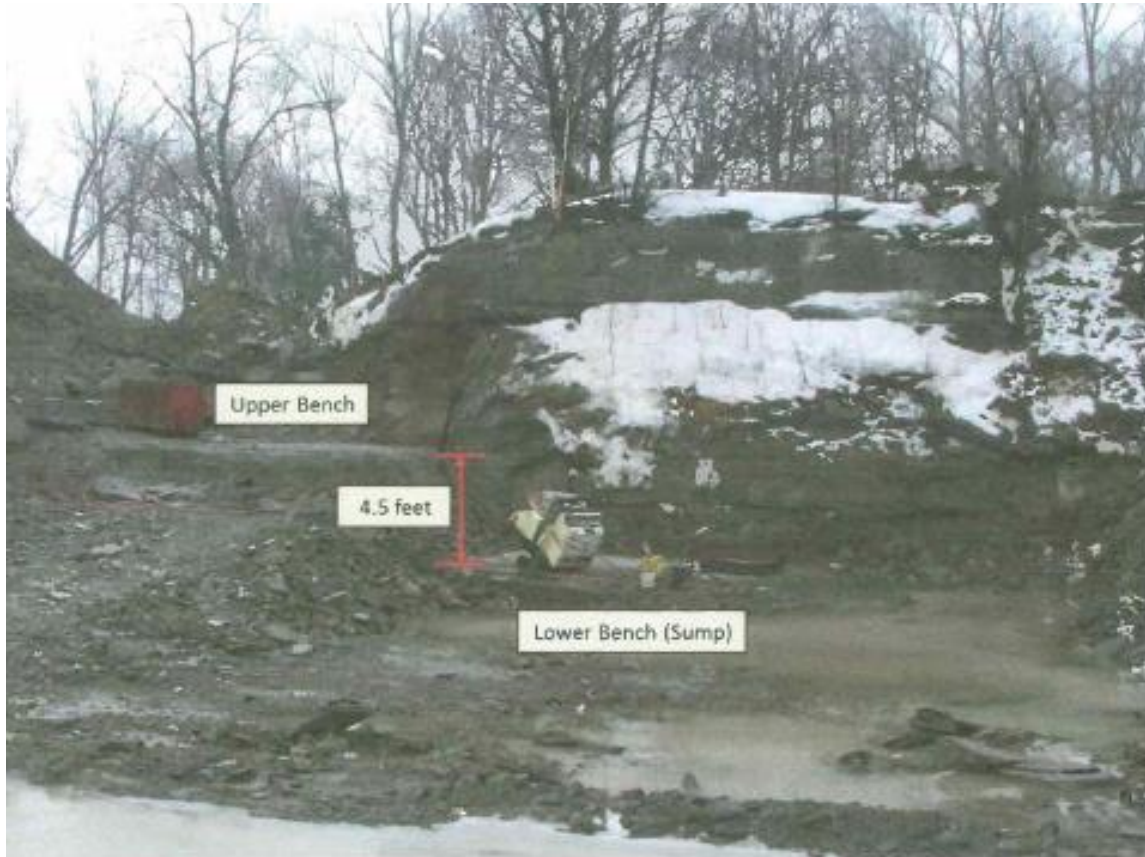
## ACCIDENT SCENE PHOTO

**Victim was sawing stone blocks on the upper bench when he fell to the lower bench below (sump area) and the saw fell on top of him.**

The victim failed to maintain control of the self-propelled concrete saw that he was operating in reverse gear while repositioning to cut stone. No procedures were in place for persons to safely operate the walk-behind, self-propelled concrete saw on an elevated bench.

- Identify all hazards and use appropriate controls to protect miners prior to conducting any work.
- Ensure that operators are in a safe position and have control of their equipment at all times.
- Keep workplaces free of tripping hazards.
- Use barricades or railings at edges of drop-offs where persons are in danger of falling.

- Equip walk behind masonry saws with automatic shut off devices to stop the engine if the operator cannot maintain control of the equipment.
- Design bench top stone cutting patterns to ensure the saw operator is not positioned between the saw and the drop off edge.
