Hycroft Mine

Hycroft Resources & Development Inc.

Fatal Accident: May 28, 2015

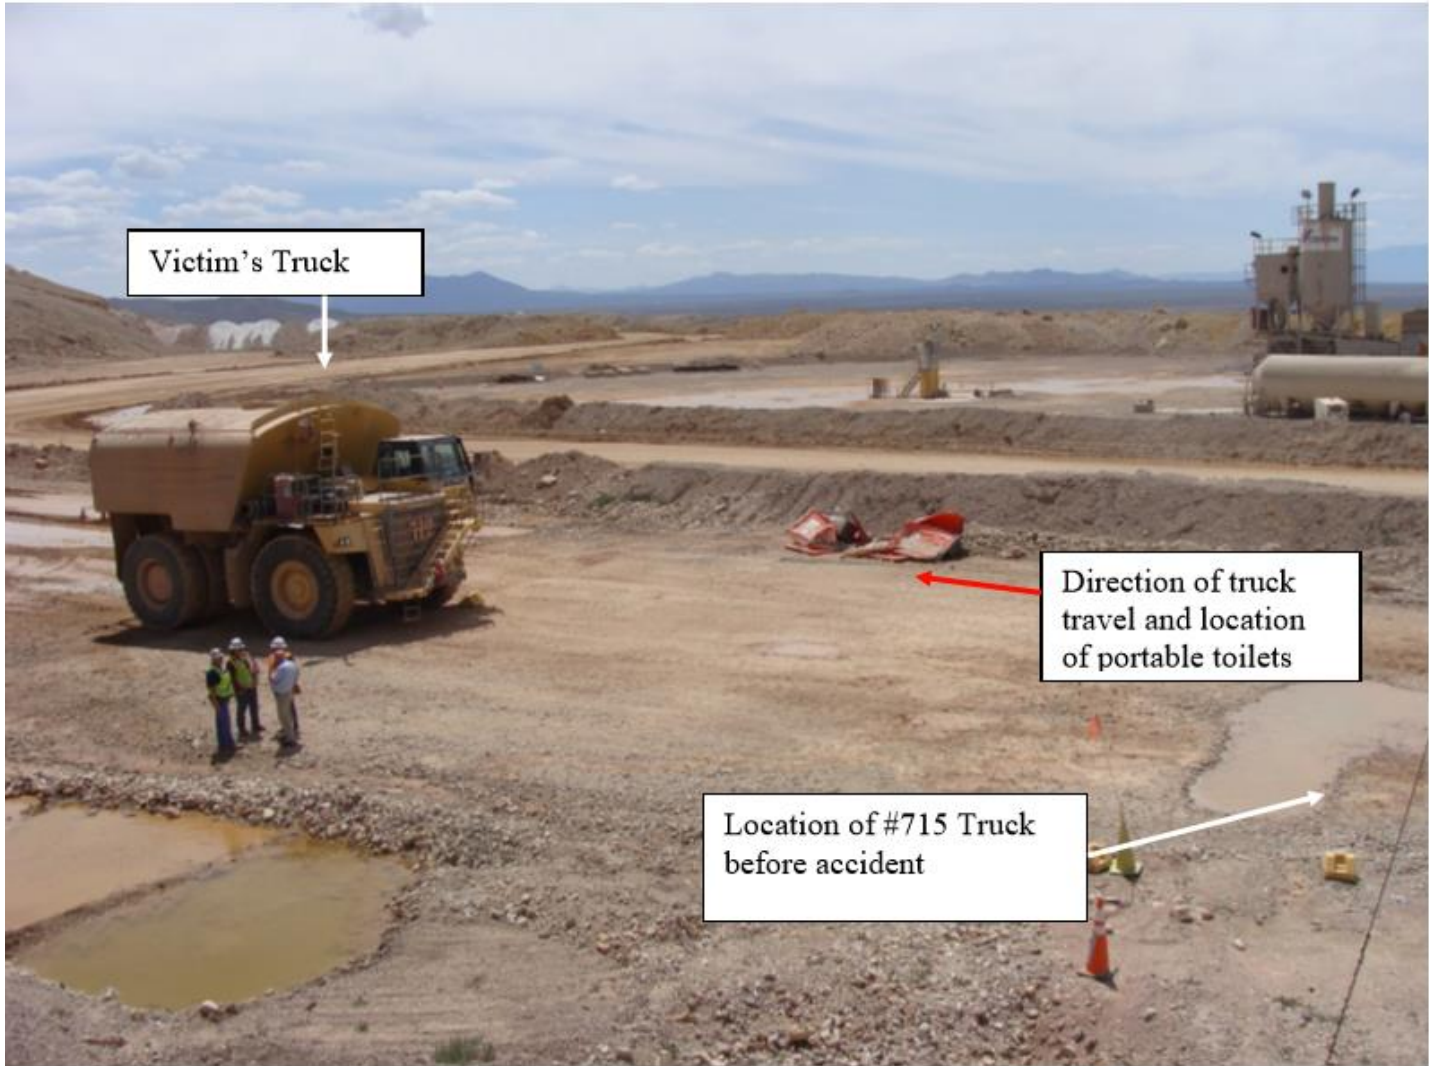
Victim's Truck

Direction of truck travel and location of portable toilets

Location of #715 Truck before accident

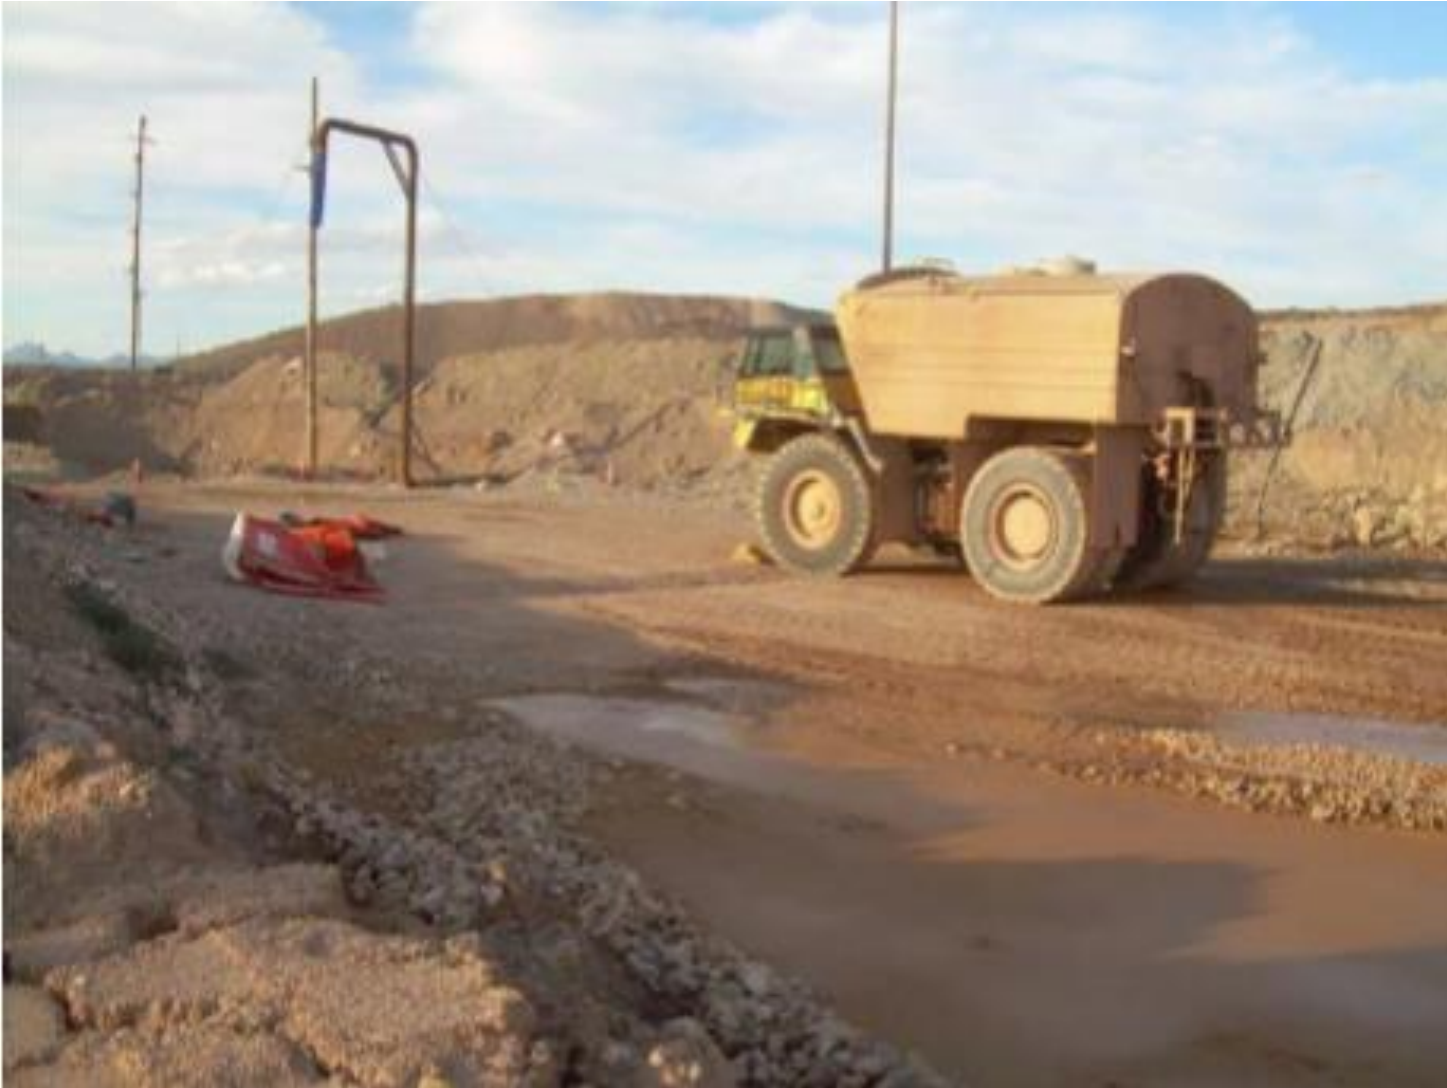
There was a berm constructed on the West side, or behind the portable toilets, to provide protection from the haul road that was heavily traveled. There were not berms for protection against traffic utilizing the water stand pipe area however.

- Locate portable toilet facilities in areas inaccessible to mobile equipment. Always be aware of equipment operating in close proximity to your area.
- Ensure all persons are clear before moving equipment.
- Sound your horn to warn persons prior to moving mobile equipment and wait a few moments to give them time to get to a safe location.
