# Hanson Aggregates Midwest, LLC Dry Fork Sand & Gravel

Fatal Accident: July 10, 2015

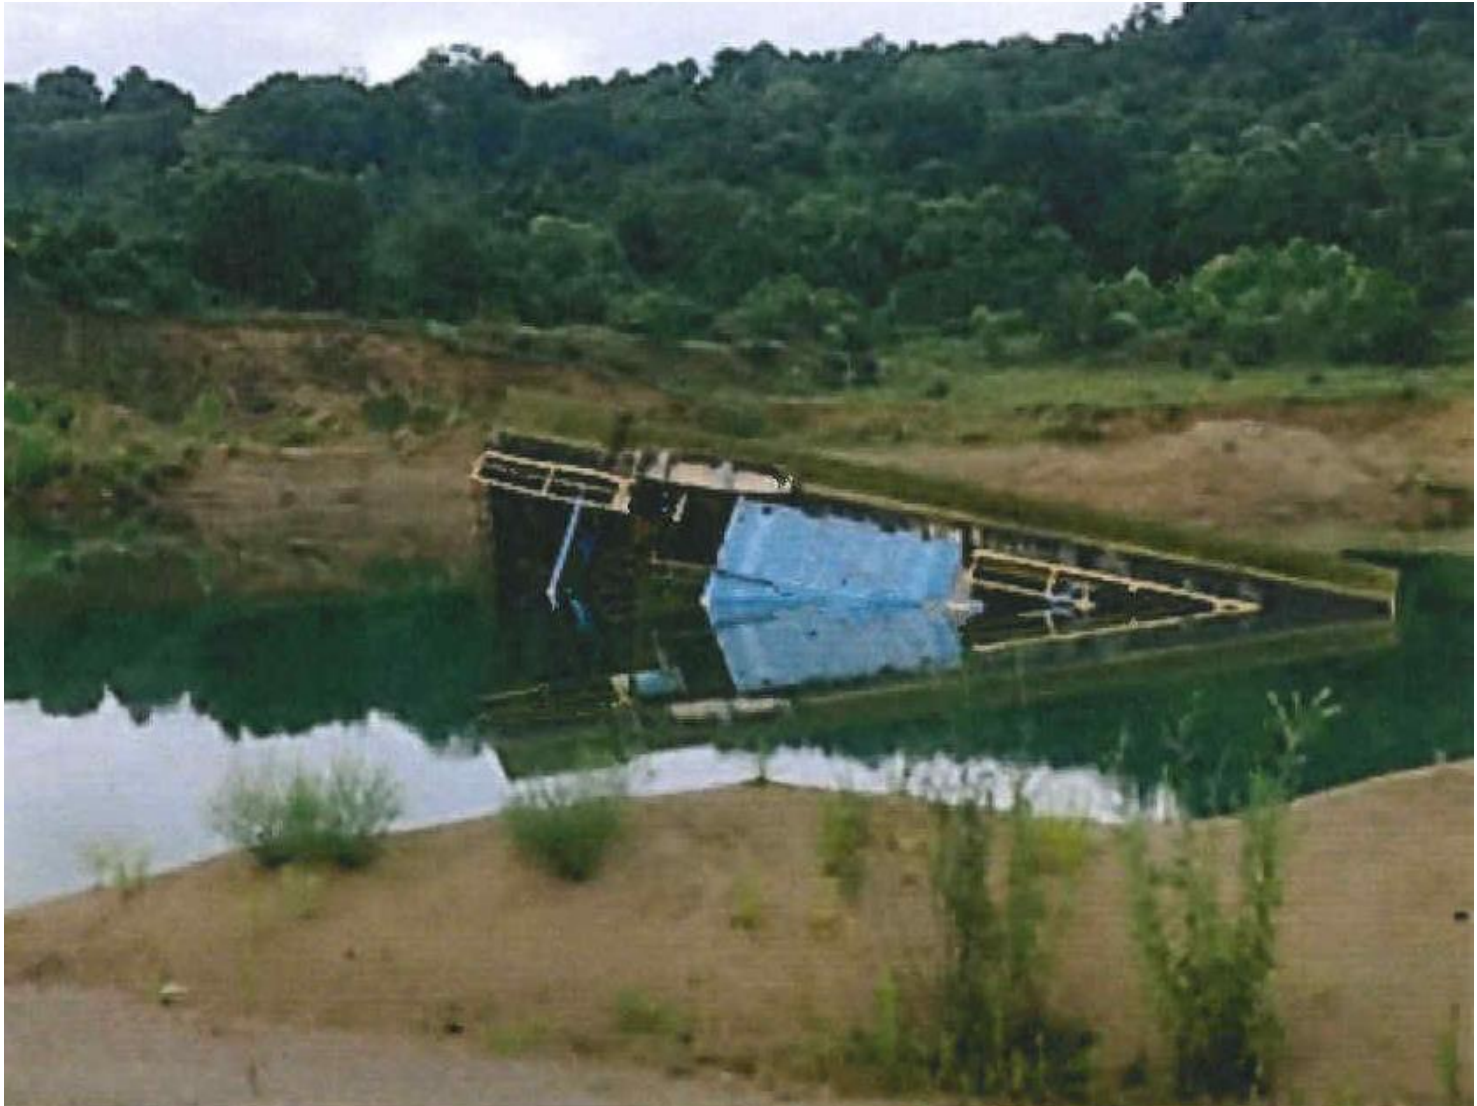
- July 10, 2015 William J. Roell, Superintendent, age 50 was killed while operating a dredge
- Roell and another miner were attempting to dislodge the clamshell bucket from the bottom of the lake bottom
- The dredge capsized

- The miner was injured when he was thrown from the dredge as it capsized, was able to swim ashore
- Divers recovered Roell from the motor control center room in the submerged dredge eight days later
