Green Brothers Gravel Company Harmony Mine & Mill

Fatal Accident: June 3, 2016

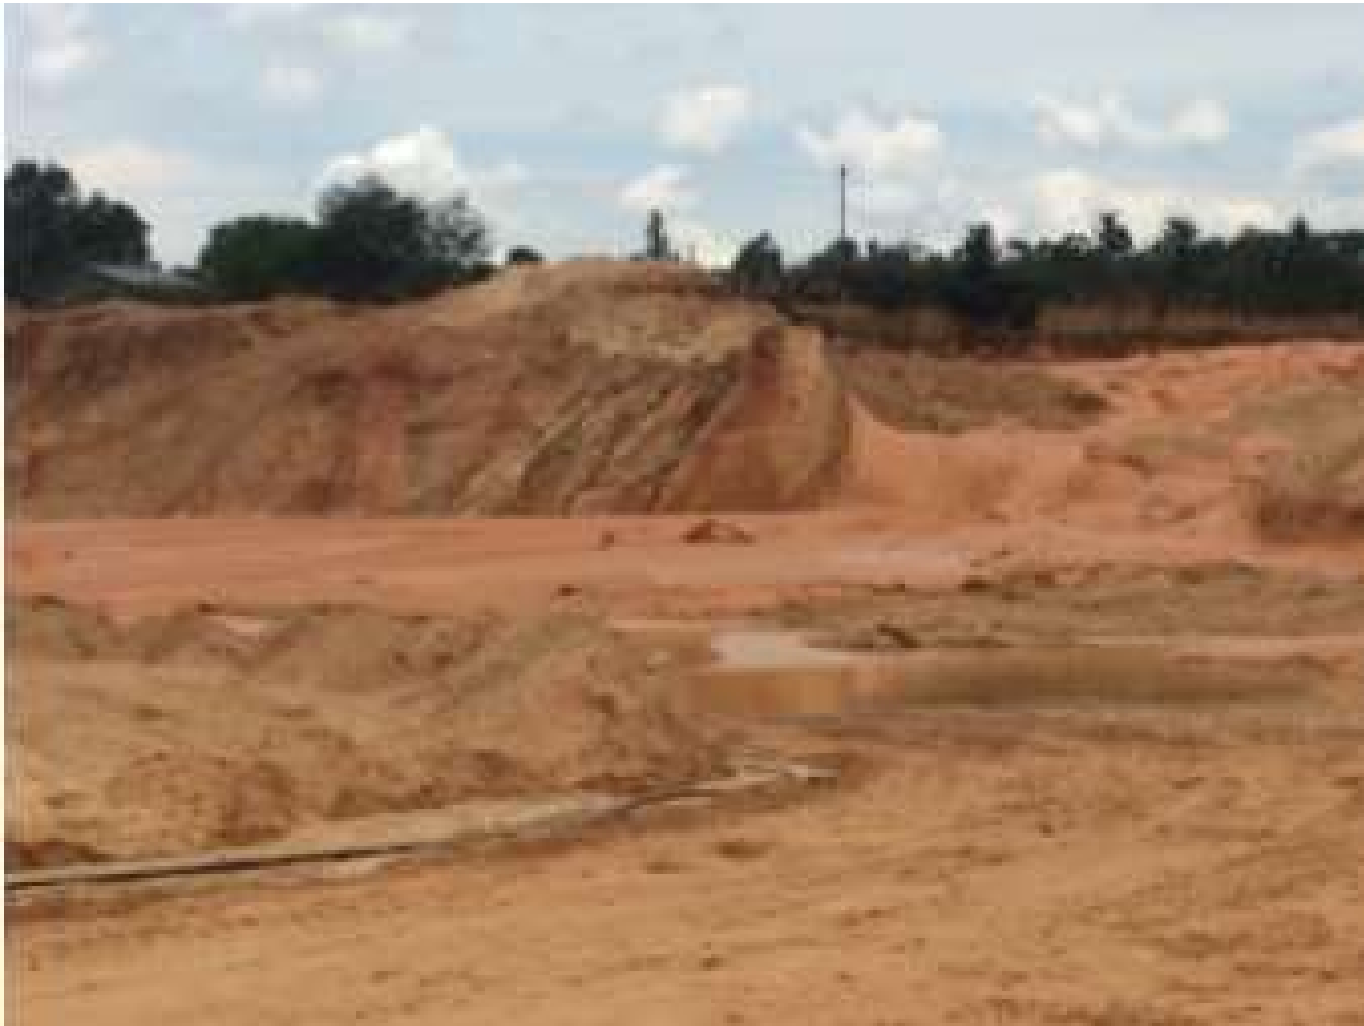
The excavator was positioned near the east pit wall facing a northern direction at the time of the failure. The truck was on the west side of the excavator, and was facing south to southeast.
