M-Class Mining  
LLC  
MC #1 Mine  
Macedonia, IL

# COAL MINE FATALITY

APRIL 11, 2010

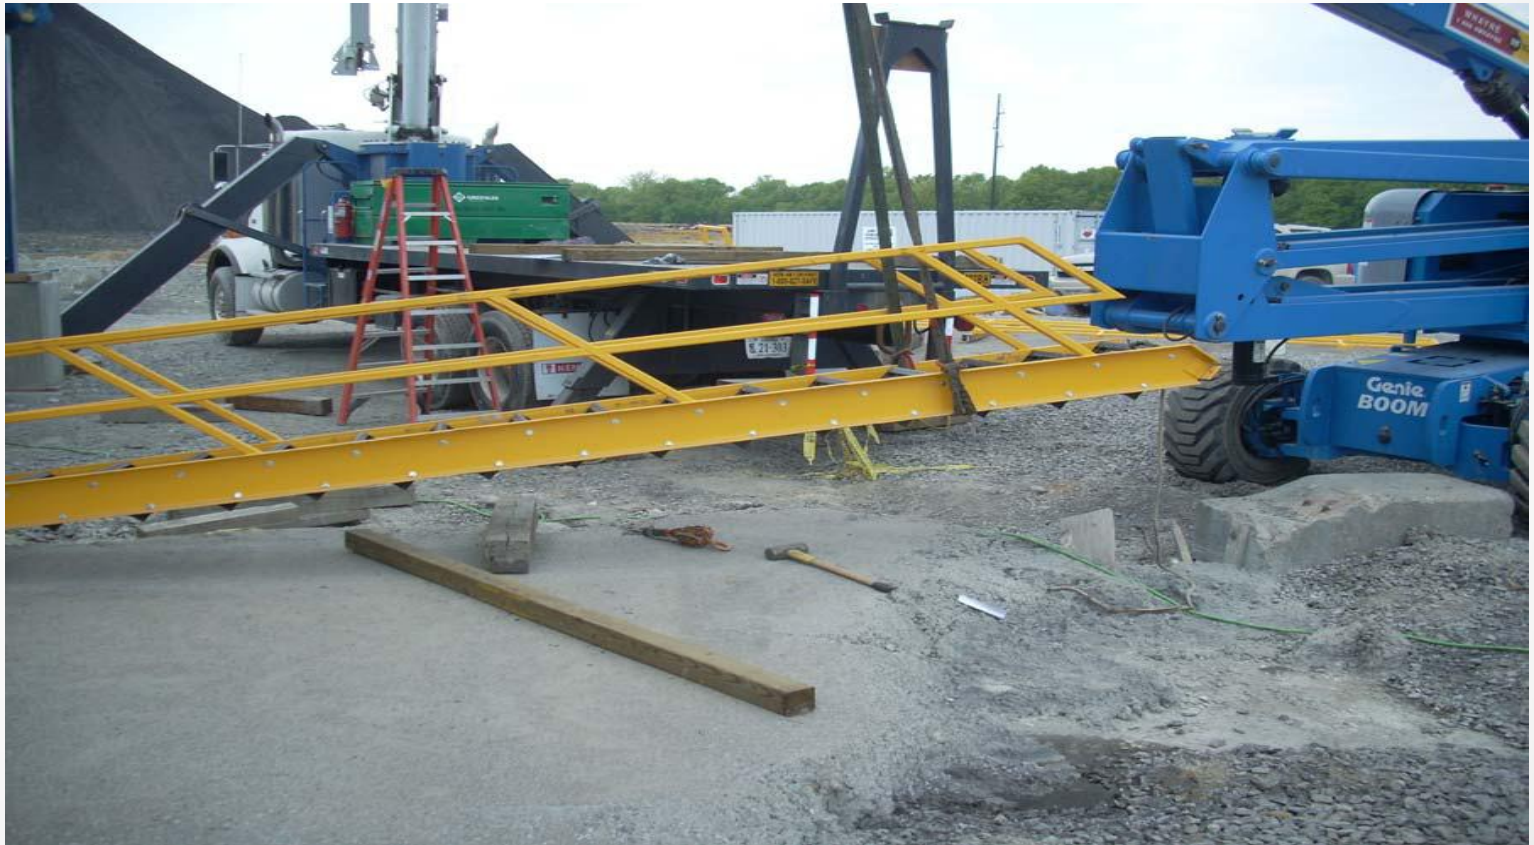
# ACCIDENT SCENE

- As the lower end of the stringer was hoisted by crane, the clamps opened and the top end of the stringer fell.
- This caused the bottom end of the stringer to pivot up and out.
- This pushed the victim backward approximately 8 feet until he contacted the nearby man lift being used to position another worker to clamp the stringer in place.
- As he was backed against the manlift, the victim was struck in the chest by the bottom step of the stair stringer.

- Ensure that all personnel stay clear of hoisted loads and areas where loads may fall if hoisting fails.
- Know the limitations of temporary supports and ensure they are used within their specifications.
- Ensure all components are adequately blocked and secured to prevent unintended motion.
- Use taglines on loads to be hoisted that will need steadying or guidance.

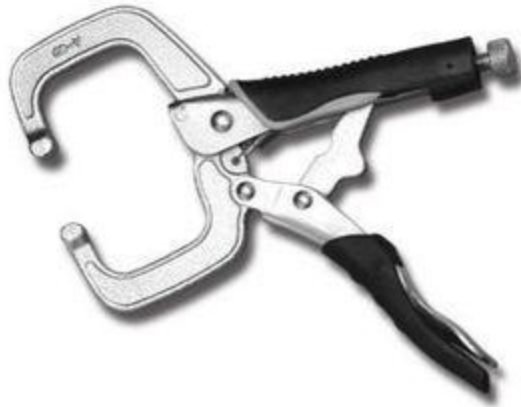
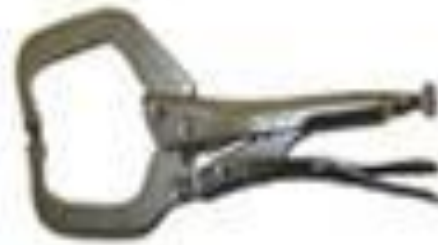
# LOCKING C-CLAMPS

- A 61 year old iron worker/mine fire boss with 20 years of mining experience was fatally injured while installing pre-fabricated metal stairs on the side of a fan housing.
- The stair stringer had been hoisted into place and clamped at the top with two “locking pliers-type” C-clamps.
- The bottom of the inclined stringer was lying on a 6” x 6” timber.
- To level the stair treads, a 6” x 6” timber was going to be replaced with a 4” x 4” timber.
