Freeport-McMoRan Safford Mine

Fatal Accident: April 9, 2016

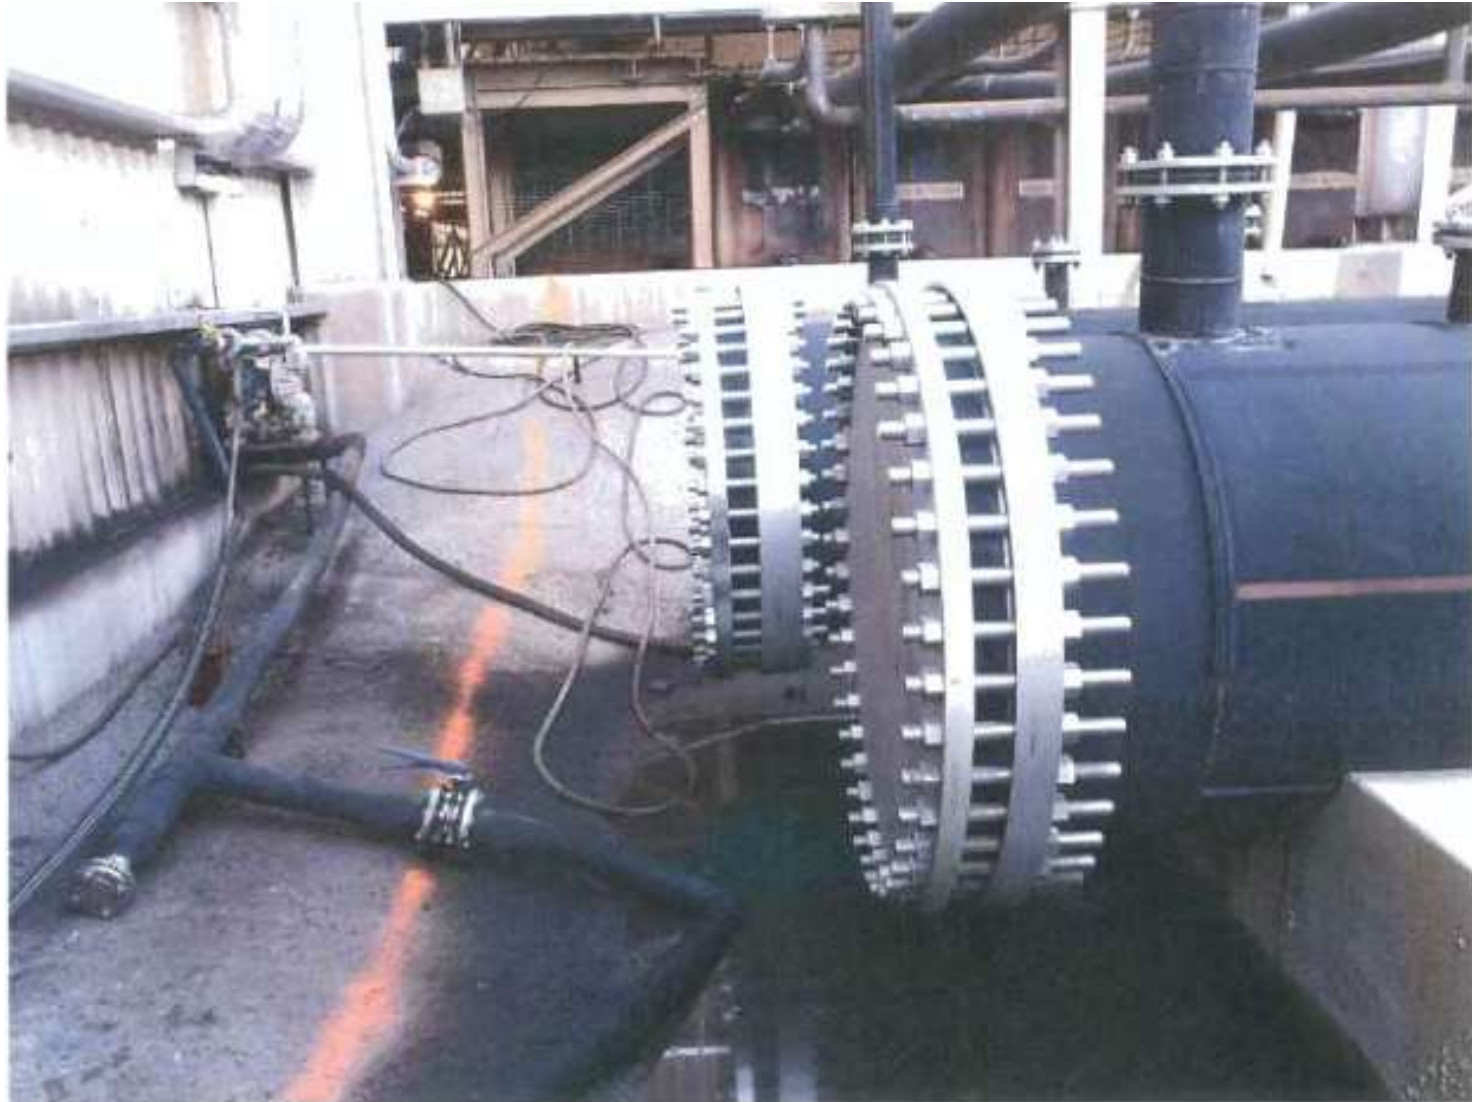
- April 9, 2016 Bryan Ortiz, Hydromet Electrowinning Operator, age 25 was seriously injured when he was electrocuted by an energized flange
- He was informed to prime a pump
- Found incapacitated kneeling in electrolyte solution

- His head was contacting an energized flange
- Ortiz died of his injuries on April 10, 2016

Management failed to ensure that the stainless steel endcaps on the HDPE electrolyte return lines were not electrified when the rectifier circuits were energized.

Corrective Actions: Management has placed insulating covers over metal flange fittings and provided a fence around the area to prevent accidental contact.
